Diagnosis and Repair Bulletin

**Subject: Six-Cylinder Camshaft
Pin Breakage**

**Application: 1977-80 Jeep Vehicles
With Six-Cylinder Engines**

No. 80-3 Feb. 4, 1980

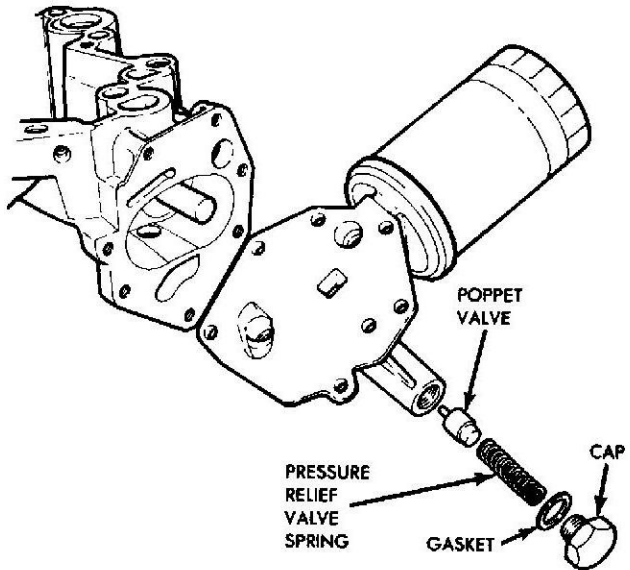
Pressure Relief Valve Assembly

Some 1977-1978 V-8 engines may have oil pressure gauge readings that are within specifications but less than what is normal for V-8 engines. This condition may be the result of a weak pressure relief spring in the oil pump.

Service correction involves replacing the weak spring with a new replacement spring.

- (1) Check oil level.
- (2) Remove oil pressure relief valve spring by removing retaining cap from cover (see illustration).
- (3) Measure free length, if less than 3.25 inches (82.55 mm), replace spring.
- (4) Check the operation of relief valve by sliding poppet valve back and forth. It should move freely.
- (5) If the spring length is 3.25 inches and poppet is free, check oil pump gear clearance as outlined in appropriate Jeep Technical Service Manual.

- (6) Assemble relief valve, spring, and retaining cap back into cover.
- (7) Torque retainer cap to 28 foot pounds (38 newton-meters) torque.
- (8) Start engine and check oil pressure and check for oil leaks.

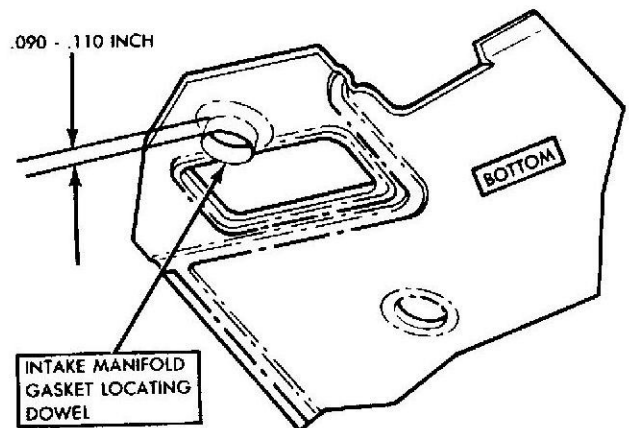
Fig. 1 Intake Manifold Gasket Locating Dowel

Some 1978 V-8 engines may have an oil consumption rate of 2 or more quarts per thousand miles at highway speeds. This may be caused by the intake manifold gasket locating dowels being too long and bottoming out in the cylinder head counter bores.

- (6) Inspect new intake manifold gasket for proper dowel length which should be between .090 and .110 inch (Fig. 1).
- (7) Install intake manifold as outlined in the 1978 Jeep Technical Service Manual, Volume I, page 1B-50.

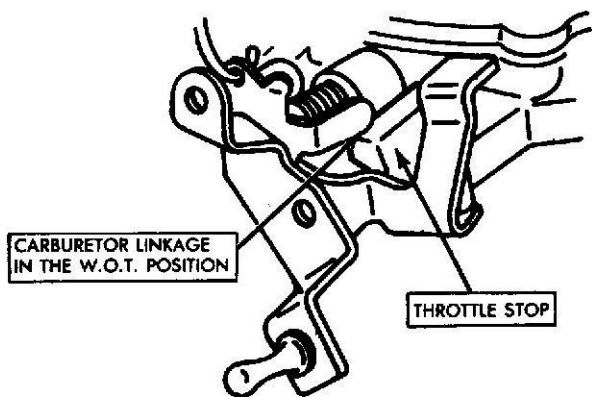
Fig. 1 258 2-V

Some owners of 1978 Wagoneer, Cherokee, and Truck models may find it difficult to obtain wide open throttle or release the choke by depressing the throttle pedal. This may be the result of inadequate throttle travel.

- (1) Position drop light for proper visual inspection of throttle linkage travel.
- (2) Push throttle pedal down to wide open throttle position.
- (3) Observe position of carburetor linkage in relationship to throttle stop (see figures 1, 2, and 3).

(4) If carburetor linkage contacts throttle stop, throttle linkage geometry is correct. Proceed to step (5). If linkage does not contact throttle stop, proceed to Repair Procedure.

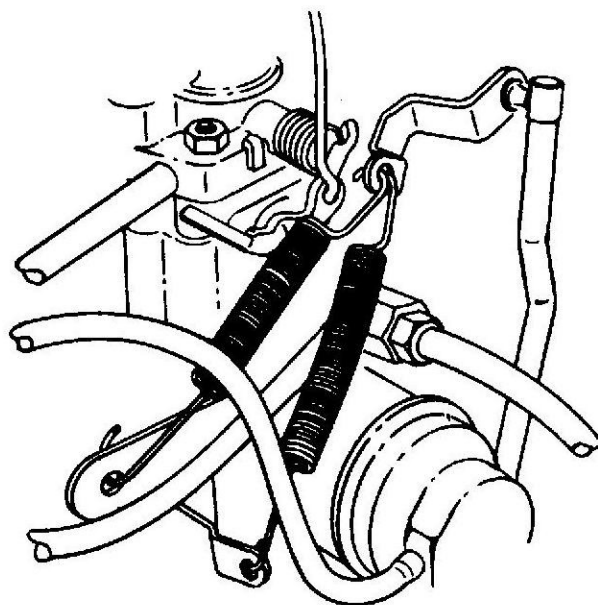
Fig. 1 Carburetor Return Springs

Another accelerator return spring is being added to all 1978 Jeep Cherokee and Truck models with a 258 CID engine and 2V carburetor, built between VINs J8XXXXC000008 and J8XXXXC037866, to assure that the throttle will close rapidly under the most extreme operating conditions.

- (1) Connect short end of accelerator return spring into carburetor lever-to-accelerator cable bracket (in same hole as existing spring) (see Figure 1).
- (2) Connect long end of accelerator return spring into forward hole of carburetor pull back spring bracket (see Figure 1).
- (3) Check throttle operation.
