Diagnosis and Repair Bulletin

Subject: Six-Cylinder Camshaft Pin Breakage

Application: 1977-80 Jeep Vehicles With Six-Cylinder Engines

No. 80-3 Feb. 4, 1980

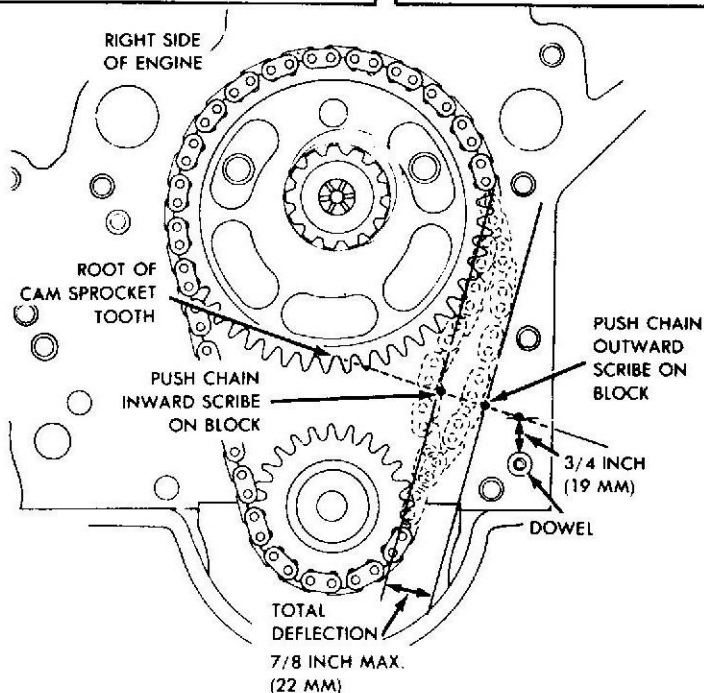
The new timing chain has different deflection characteristics than does the previous design chain. The following chain deflection inspection measurement procedure is required to determine the necessity for replacement.

Camshaft And Crankshaft Sprockets And Timing Chain As Viewed From Front Of Engine

- (4) Push chain in toward centerline of engine and mark block at point of maximum inward chain deflection.
- (5) Pull chain outward from centerline of engine and mark block at point of maximum outward chain deflection.
- (6) Measure between the two marks to determine total deflection.
- (7) Replace chain assembly if deflection (wear) exceeds 7/8 inch (22 mm).
- (8) Install timing case cover following procedure in appropriate Technical Service Manual.

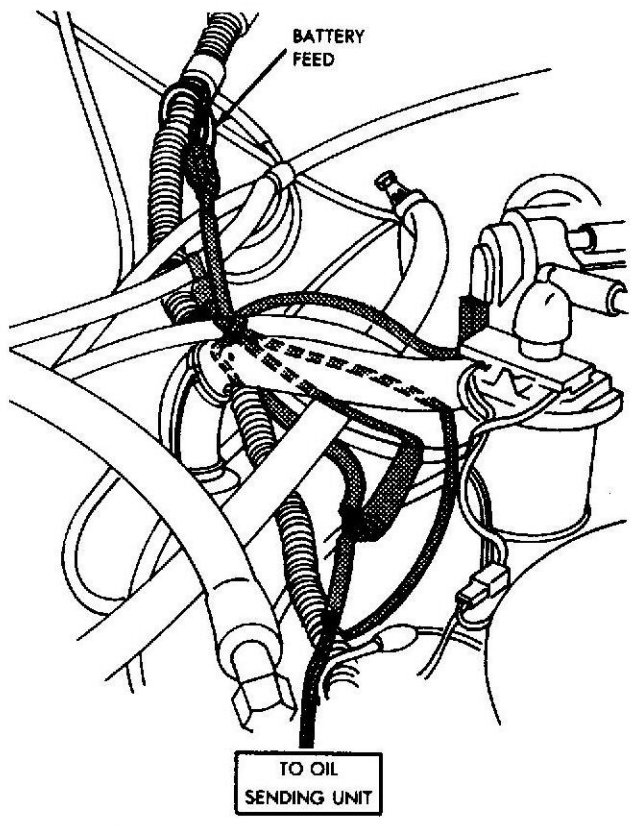
Manual Transmission Vehicles

Some 1979 Wagoneer, Cherokee and Truck models may have a choke jumper harness routed too close to the choke heat tube or exhaust manifold. A new choke harness routing procedure and replacement choke harness have been developed for extreme cases having choke harness heat damage.

- (1) Remove air cleaner.
- (2) Inspect choke jumper harness for proper routing and/or heat damage from choke heat tube or exhaust manifold (see illustration).
- (3) If choke jumper harness has heat damage, inspect engine harness for possible related damage.
- (4) Inspect oil pressure sending unit as described in Chapter 1L of 1979 Jeep Technical Service Manual.

- (1) Route choke jumper away from exhaust manifold and choke tube (see illustration).
- (2) Install nylon tie strap around engine harness and jumper harness loom approximately 1 inch from end of loom (see illustration).

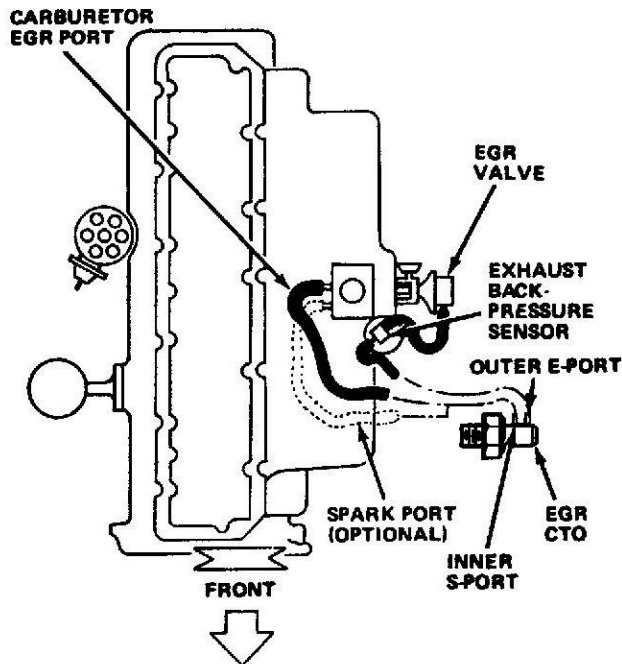
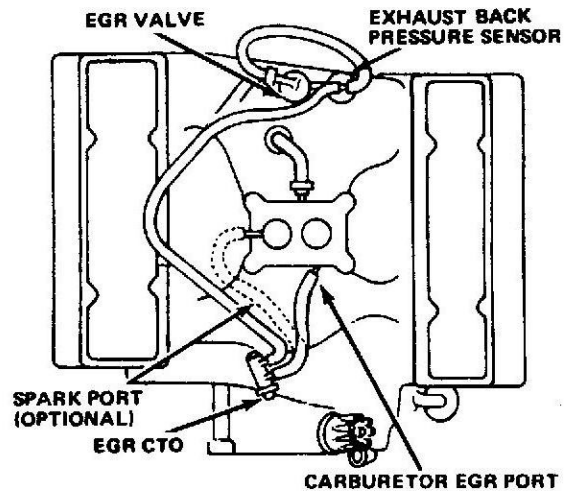
Some 1974-1979 Jeep vehicles have defective exhaust gas recirculation (EGR) back-pressure sensor valves. (Refer to Jeep Application Chart for model year and engine displacement.) Service correction involves replacing the EGR back-pressure sensor with a newly designed sensor (regardless of sensor's present condition), performing an idle mixture adjustment on all 6-cylinder engines, and affixing a Campaign Label (8-cylinder) or a combined Campaign and 6-cylinder Lean

Vacuum Hose Routing for 6-Cylinder 42014

Vacuum Hose Routing for 8-Cylinder AJ41263

- 1) Remove air cleaner.
- 2) Remove vacuum lines from exhaust back-pressure sensor and EGR valve.
- 3) Remove EGR valve, back-pressure sensor, restrictor plate (if applicable), and gaskets.
- 4) Manually pull EGR valve pintle off seat to ensure freedom of movement. If EGR valve pintle moves freely, proceed to step (5).
If EGR valve pintle does not move freely, clean pintle area. If pintle does not move freely after cleaning, replace EGR valve and proceed to step (6).
- 5) Clean EGR valve mounting surface.
- 6) Clean manifold, restrictor plate (if applicable), and all mating surfaces.
- 7) Using new gaskets, install restrictor plate (if applicable), new back-pressure sensor, and EGR valve. Tighten attaching nuts to 13 foot-pounds (17 N.m) torque.
- 8) Connect vacuum lines to back-pressure and EGR valve (See Figure 2-A & 2-b). If vacuum lines show signs of deterioration replace them.

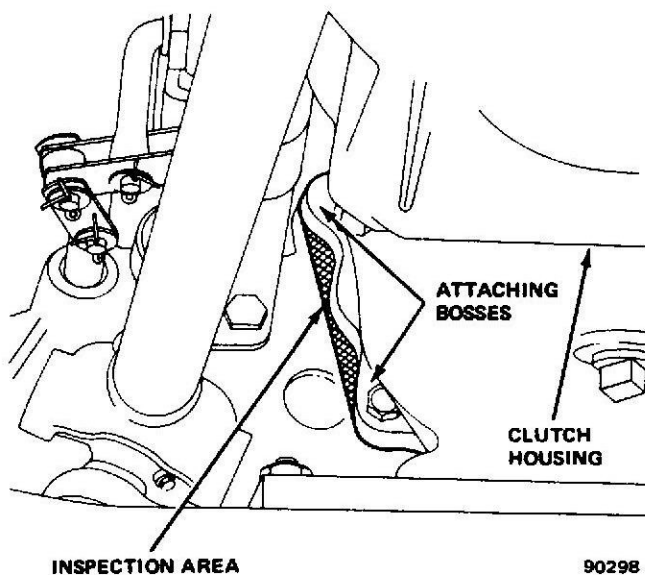
Fig. (1) Inspection Area

- (c) If correct gasket is in place, lower vehicle and return to owner. If incorrect gasket was installed, replace gasket. Refer to gasket replacement procedure.

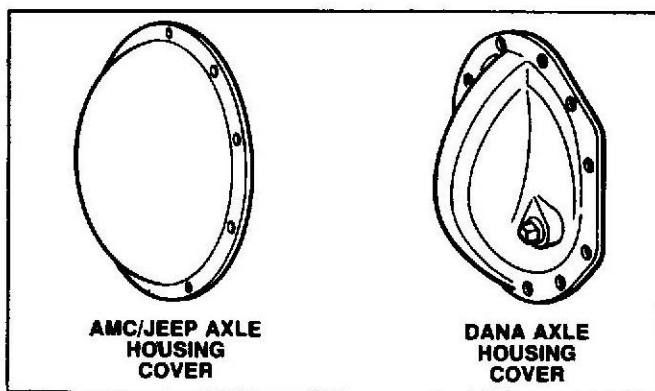
Fig. 1 Axle Housing Cover Identification

- (1) Raise and support vehicle.
- (2) Inspect rear axle housing cover to determine what type of axle is in vehicle.
 - (a) If axle has round, dome shaped cover (Fig. 1), vehicle has AMC/Jeep axle and will require repair if campaign identification mark is not present. Place campaign-inspection identification paint mark on cover (Fig. 1) and proceed to repair procedure.
 - (b) If axle has oval, irregular shaped cover (Fig. 1), vehicle has Dana axle and does not require any repairs.
- (3) Lower vehicle.

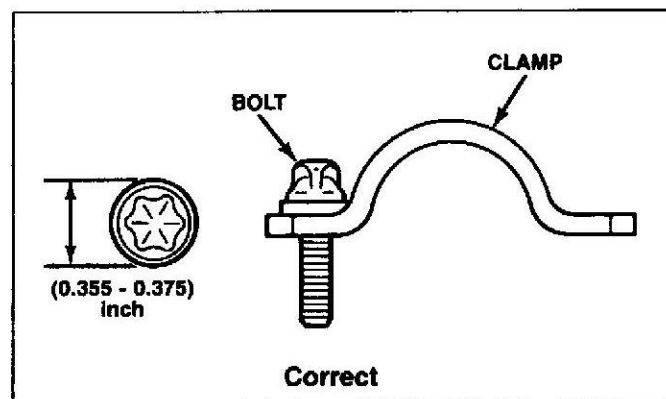
Fig. 1

If all bolt heads have small flange (Fig. 1) and there is no interference with clamp, clean yoke using wire brush and shop cloth with solvent. Color every yoke with dab of light colored paint where screws and clamps were correct to note campaign completion, and return vehicle to owner.

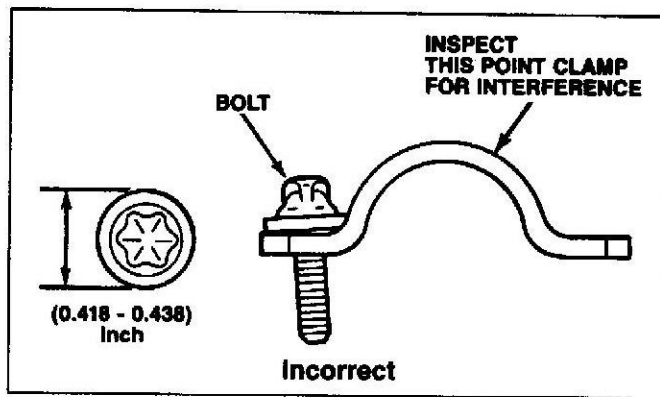
Fig. 2

If any bolt heads have large flange (Fig. 2), then clamp and bolts must be replaced. Refer to the Replacement Procedure.

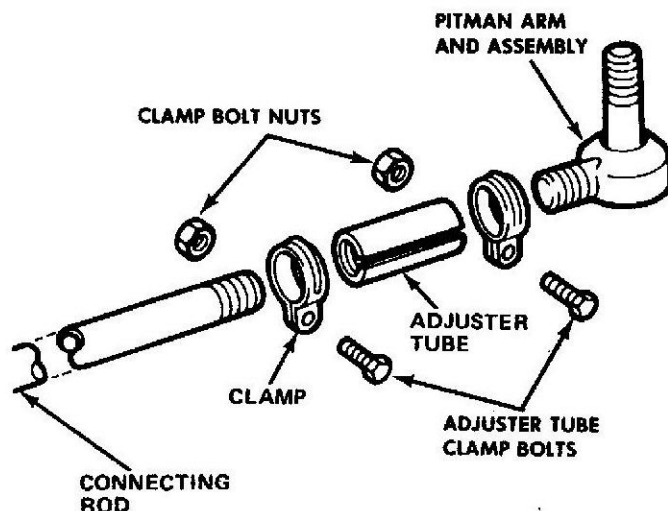
Fig. 1 Adjuster Tube Clamp Bolt Location

5. If both clamp bolts are loose but steering wheel alignment is correct, tighten bolts to 12 foot-pounds (16.Nm) torque and return vehicle to owner or to stock. If both clamp bolts are loose and steering wheel alignment is incorrect, proceed to next step.
6. Place steering wheel in aligned position and secure wheel using steering wheel holder.
7. Turn adjuster tube until front wheels are in straight-ahead position. Verify wheel position using alignment rack.
8. Tighten adjuster tube clamp bolts to 12 foot-pounds (16.Nm) torque.
9. Remove vehicle from alignment rack and return vehicle to owner or to stock.

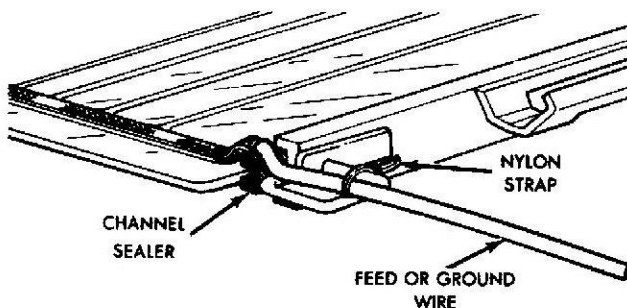
Fig. 1 Defogger Wire Interference

- (1) Remove tailgate glass and channel assembly as outlined in appropriate Jeep Technical Service Manual.
- (2) If wire(s) requiring repair is not broken, remove nylon strap and cut wire(s) adjacent to tailgate glass lower channel (see fig. 1).
