FILE: Engines-Fuel Systems  
Engine Electrical-Cooling  
(POWER PLANT-Engines)  
No. 1-10-82 Sept. 8, 1982

## TECHNICAL BULLETIN

# Diagnosis and Repair Bulletin

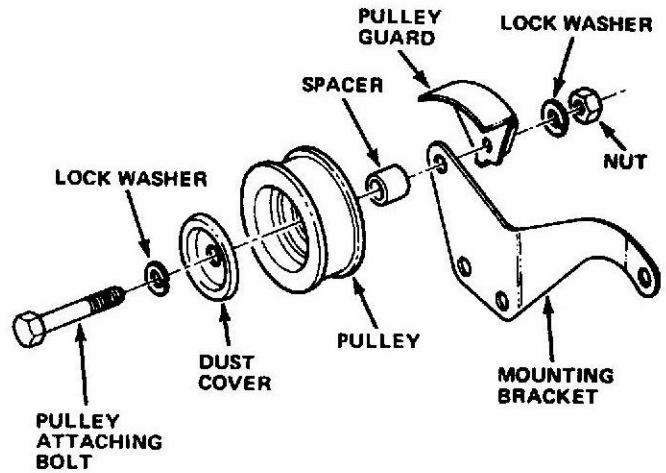
**Air Conditioning Back Idler Pulley Assembly**

On some 1981 California Jeep Cherokee, Wagoneer, and Truck models built prior to VIN 1JTNA25N5BT015502 and equipped with a six-cylinder engine and air conditioning, the air conditioning back idler pulley or the pulley attaching components may have been installed or assembled incorrectly. This condition could result in a chirp noise from the idler pulley assembly during vehicle acceleration, or whenever engine speed is increased rapidly.

- (1) Inspect idler pulley attaching bolt and note if lock washer has or has not been installed between bolt head and idler pulley dust cover (see illustration).
- (2) Loosen alternator adjusting bolt and release tension on serpentine drive belt.
- (3) Remove nut and lockwasher from idler pulley attaching bolt and remove bolt and pulley components as assembly.
- (4) Carefully disassemble idler pulley components and inspect as follows:
  - (a) Check to see if flat washer was incorrectly installed between idler pulley dust cover and idler pulley. Discard flat washer if a washer was installed.

- (b) Check for idler pulley being installed in reverse position. Deepest counterbore in pulley hub should be facing forward (see illustration). Correct pulley position if necessary.

- (5) Assemble idler pulley, dust cover, spacer, and pulley attaching bolt and lock washer. Refer to illustration for correct assembly sequence. Be sure pulley is correctly positioned and that lockwasher is installed on pulley attaching bolt.
- (6) Position idler pulley assembly on mounting bracket and install lockwasher and nut on pulley attaching bolt. Tighten nut to 36 foot-pounds (49 N·m) torque.
- (7) Adjust serpentine belt tension to 140-160 pounds (623-712 Newtons) force and tighten alternator adjusting bolt to 18 foot-pounds (24 N·m) torque.

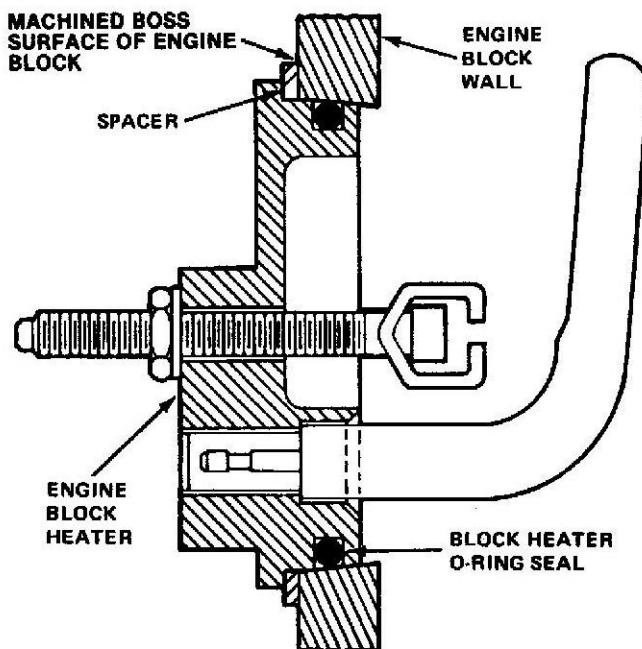
## Engine Block Heater (Compression Nut-type) and Spacer Installation

On some 1981 Jeep six-cylinder engines equipped with an engine block heater and built prior to engine build date code 011C01, the block heater O-ring seal may not contact the block properly and allow coolant to leak past the seal. This condition is due to variations in engine block wall thickness which may cause heater installation depth to be too great.

(4) Measure thickness of engine block wall at horizontal center of machined boss. If wall thickness is less than 0.36 inch, it will be necessary to install a spacer on engine block heater (see illustration).

- (5) Check block heater O-ring seal for damage.
- (6) Install block heater and spacer assembly, if required, in engine block.
