FILE: Engines-Fuel  
Systems-Engine Electrical-  
Cooling (POWER PLANT-  
Engine Electrical)  
No. 1-13-82 Nov. 11, 1982

## TECHNICAL BULLETIN

An inoperative Cruise Command servo on 1981-82 Jeep vehicles may be due to a cracked or broken manifold vacuum hose connector on the servo.

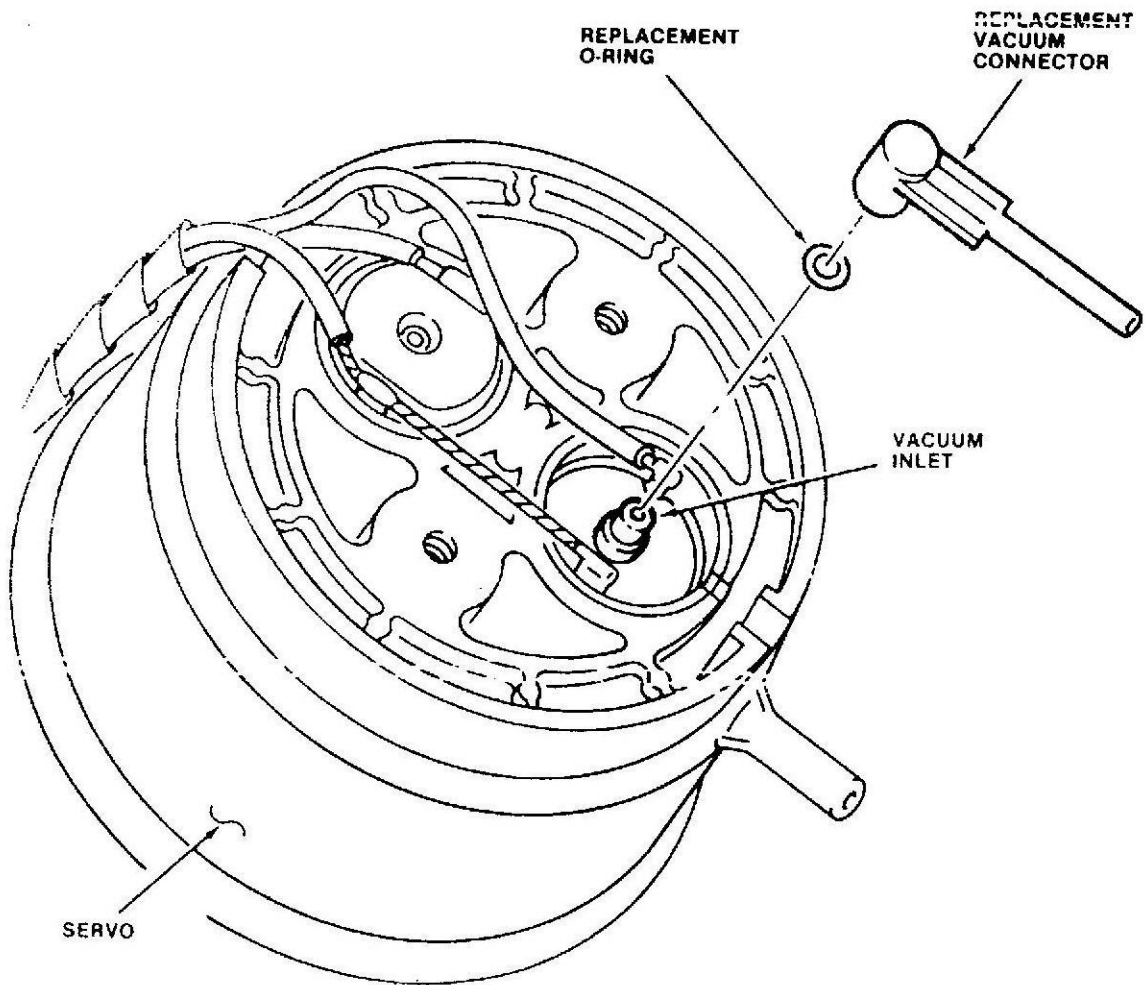
Replacement Vacuum Connector and  
O-Ring Installation

It is not necessary to replace the servo if only the vacuum hose connector is damaged. Instead, repair the servo by installing the following released vacuum hose connector repair kit.

1. Remove the servo as outlined in the applicable Jeep Technical Service Manual.
2. Remove the servo mounting bracket and plate.
3. Remove the damaged vacuum connector and O-ring from the servo.
4. Install the replacement O-ring in the replacement connector (see illustration).
5. Install the replacement vacuum connector on the servo vacuum outlet.

6. Reinstall the servo mounting plate and bracket. Be sure to avoid pinching any wires between the servo and mounting plate.
7. Install the servo as outlined in the applicable Jeep Technical Service Manual.

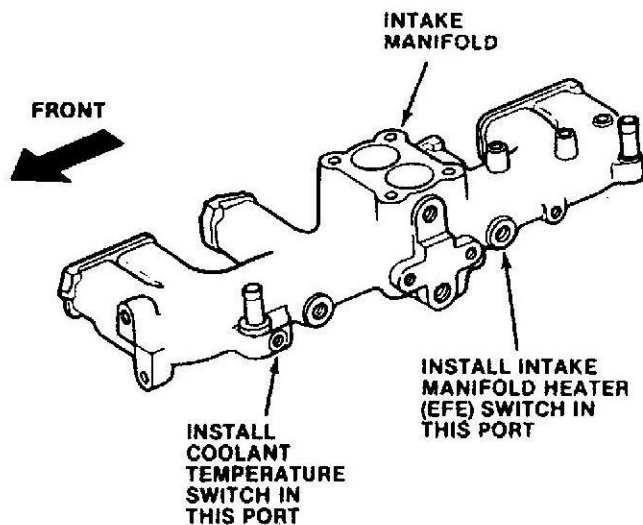
Coolant Temperature and Intake  
Manifold Heater (EFE) Switch  
Locations in Intake Manifold

6. Apply a sealer such as Perfect Seal No. 5., Loctite 592, or equivalent to the threads of replacement intake manifold heater (EFE) control switch, 3242321, and install this switch in the rear port of the intake manifold. Tighten the switch to 20 foot-pounds (27 N·m) torque.

7. Apply a sealer such as Perfect Seal No. 5, Loctite 592, or equivalent, to the threads of replacement coolant temperature switch, 324 2318, and install this switch in the front port of the intake manifold. Tighten the switch to 20 foot-pounds (27 N·m) torque.

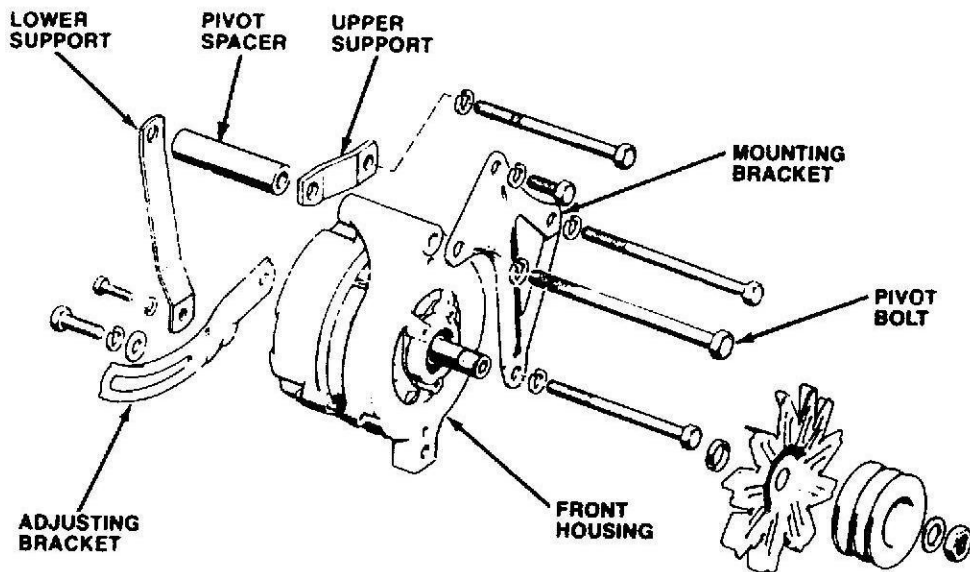
The front housing of some 70 and 85 amp alternators on 1981-82 Wagoneer, Cherokee, and Truck models with eight-cylinder engine and air conditioning may crack at the upper mounting boss and cause a vibration.

**Alternator Bracket Lower Support Installation**

Replace the alternator front housing if necessary and install the following alternator bracket lower support to improve alternator mounting (see illustration).

9. Position the alternator in the mounting bracket and install replacement pivot spacer 4006186 (see illustration).
10. Align the bolt holes in the alternator mounting bracket, front housing, upper and lower supports, and the pivot spacer, and install the alternator mounting bolt (see illustration).

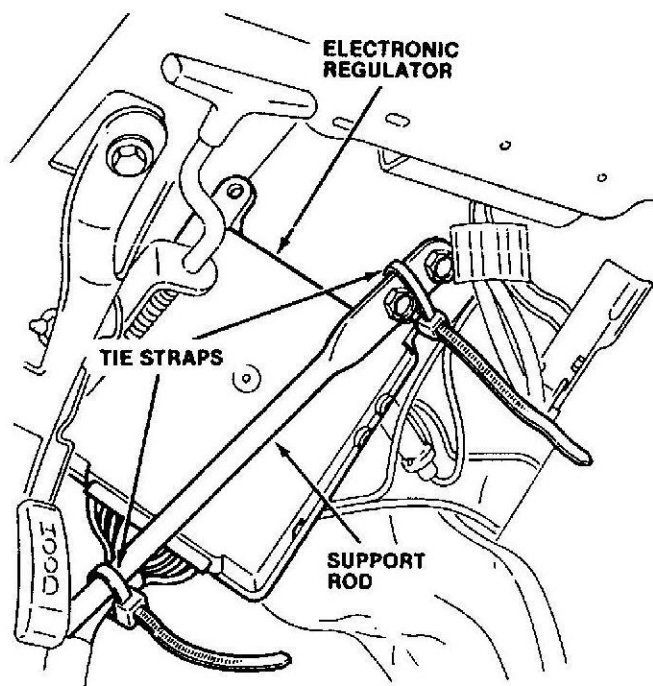
**Securing Electronic Regulator**

- (3) Secure the regulator to the lower end of the support rod by wrapping the tie strap around the regulator harness and rod (see illustration). Pull the strap tight to prevent the regulator from rotating.
- (4) Cut the ends off the tie straps approximately 1/2-inch away from the strap buckle.

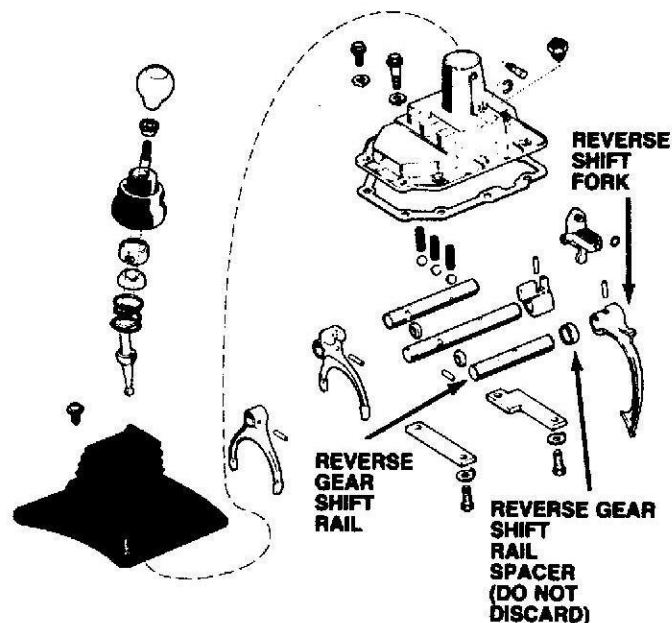
Reverse Gear Shift Rail Spacer Location

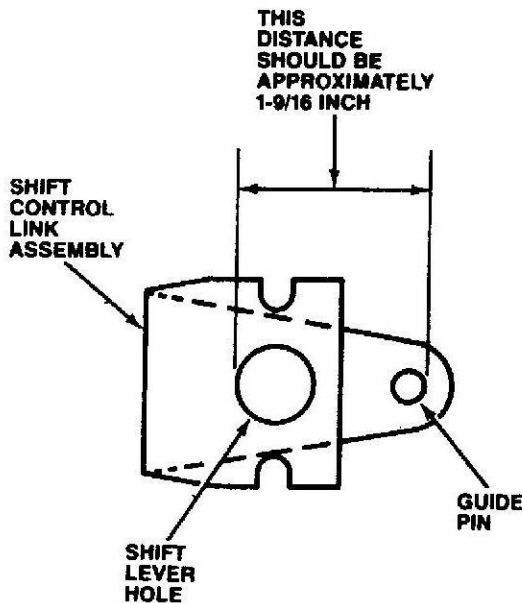
NOTE: Link assemblies that are out of tolerance will be from 1/16 to 1/8 inch over the correct distance.

Checking Shift Control Link Assembly Dimension

6. Install the replacement shift control link assembly by rotating the assembly inward and engaging it with the inner shift link pin. Be sure the link guide pin is also engaged in the shift lever link.
7. Install the outer shift control link pin and secure the link pin with a replacement cotter pin.
8. Seat the transfer case shift lever in the shift control link assembly. Insert the shifter shaft into the shift lever and install and tighten the shifter shaft nut.
9. Lower the vehicle.

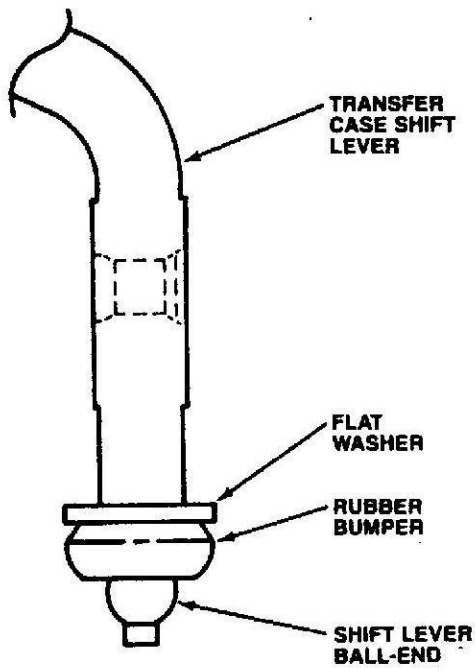
**Installing Washer and Bumper  
On Shift Lever Ball-End**

5. Seat the shift lever firmly in the shift control link. Reinsert the shifter shaft into the shift lever and front output bearing cap and install the shifter shaft nut.
6. Lower the vehicle.

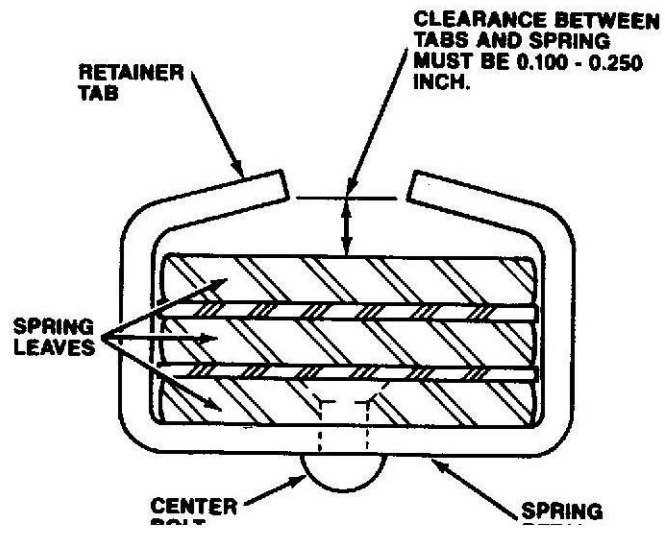
**PROBLEM AND APPLICATION:** Occasional suspension spring squeaks and a hard or stiff ride on a 1982 CJ Limited model may be caused by improperly installed suspension spring retainers. On some models, the retainer tabs were clinched flat against the spring instead of allowing the required spring-to-tab clearance.

Inspect the spring retainers and bend the retainer tabs upward as necessary to provide the required 0.100 - 0.250 inch (3 - 6mm) clearance as shown in the illustration.

**CAUTION:** Do not use an acetylene or propane torch to heat (and bend) the the retainer tabs as this could damage the spring. Use a pry bar only to bend the tabs.

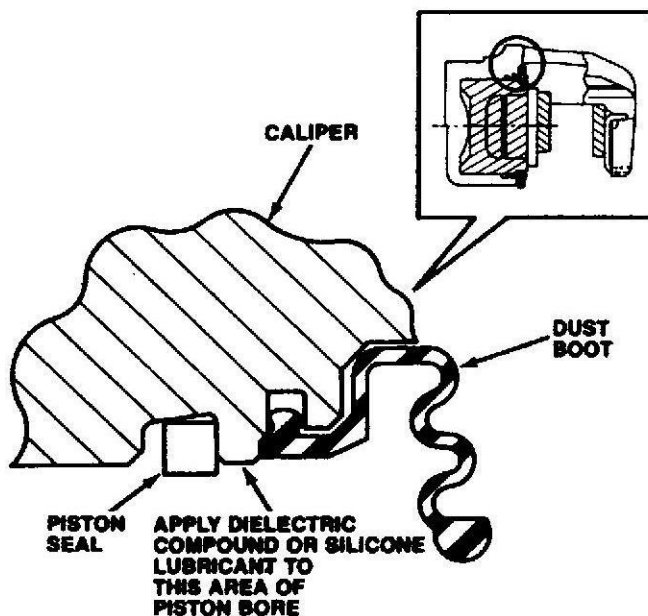
**Caliper Piston Bore Lubrication**

4. Install the dust boot as outlined in the appropriate Jeep Technical Service Manual.
5. Install the caliper piston as outlined in the appropriate Jeep Technical Service Manual. Take care to avoid wiping the Dielectric Compound or silicone lubricant from the caliper bore during piston installation.

6. Clean excess lubricant and brake fluid from the end of the caliper piston or dust boot after seating the piston in the bore.
7. Complete caliper assembly and installation as outlined in the appropriate Jeep Technical Service Manual.

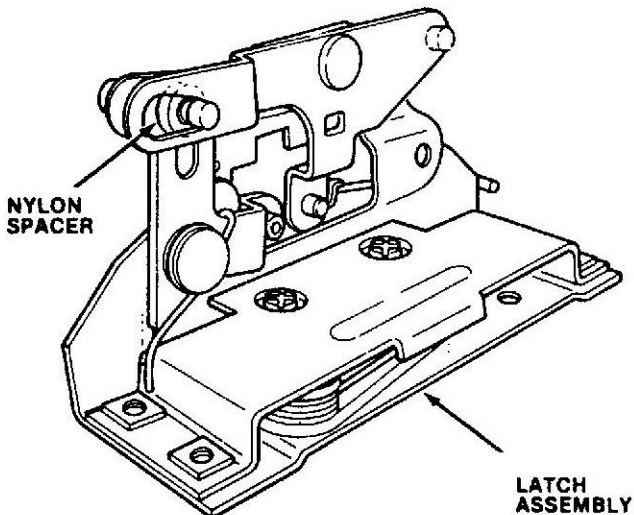
Fig. 1 — Latch Assembly Inspection

1. Remove the front door window regulator handle, door pull strap, and lower trim panel.
2. Inspect the latch assembly and control rods, and the J-shaped outside door handle rod and bushing.
  - a. Replace the latch assembly if damaged or if the nylon spacer between the lock and release levers, as shown in Figure 1, is damaged or missing.
  - b. If the latch control rod is bent or binding, it must be replaced. Do not attempt to straighten it.
  - c. Inspect the J-shaped outside door handle rod and bushing assembly. If it is bent or damaged, it must also be replaced. The rod must be equipped with a solid-type bushing as shown in Figure 2.

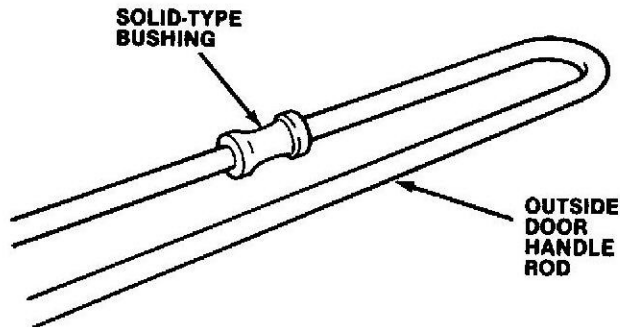
Fig. 2 — Outside Door Handle Rod and Bushing Inspection

3. Install any necessary replacement components as indicated in the previous inspection step. Refer to the appropriate Jeep Technical Service Manual for procedures.
4. Lubricate the latch mechanism and the outside door handle rod and bushing with Lubriplate or an equivalent lubricant.
5. Roll the front door window down.
6. Remove the remote control handle attaching screw and rock the handle out of the door.

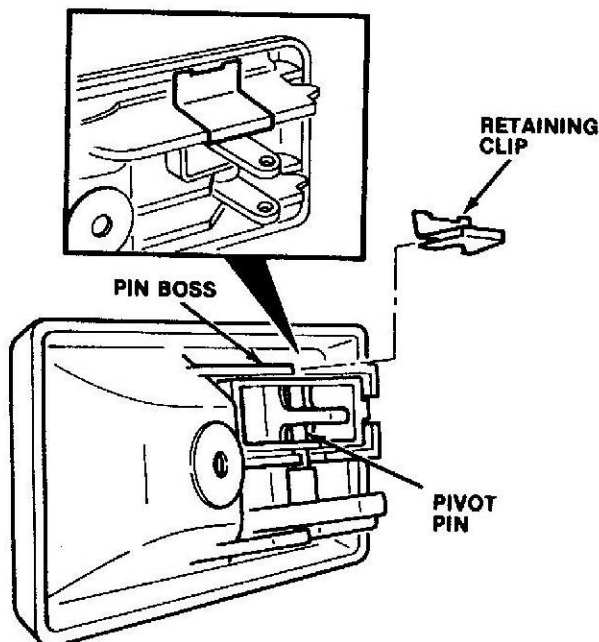
Fig. 3 — Lock Button Pivot Pin Retaining Clip Installation

7. Install retaining clip, part number 4007207, over the remote control handle lock button pivot pin and pin boss (Fig. 3). Be sure the clip notch is fully seated on the plastic pin and pin boss.
8. Install the remote control handle in the door and install the handle retaining screw.
9. Install the door lower trim panel, door pull strap, and window regulator handle if not already installed.

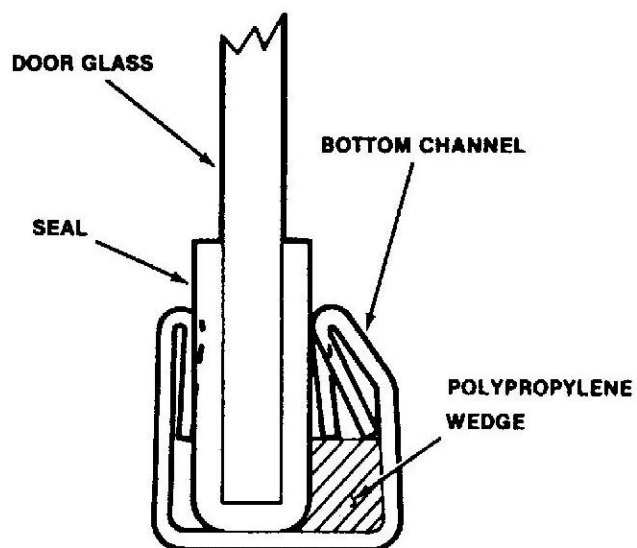
**Installing Wedges in Bottom Channel**

**Caution:** Be sure that the division and glass side channels are securely attached to the door. The bottom channel can contact the regulator if either of these channels are loose.

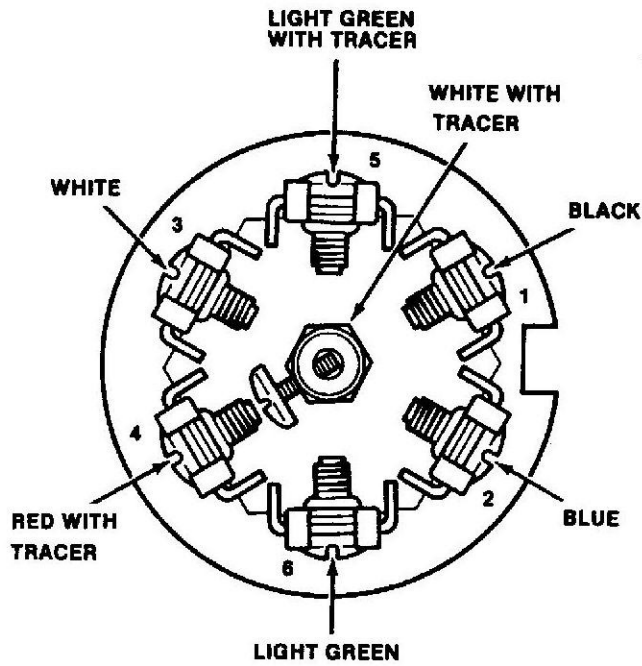
Trailer Tow Wire Harness Receptacle Connections

5. Install the receptacle and wires in the housing and seal the harness wires-to-receptacle connection with silicone sealant.
6. Verify correct harness operation.

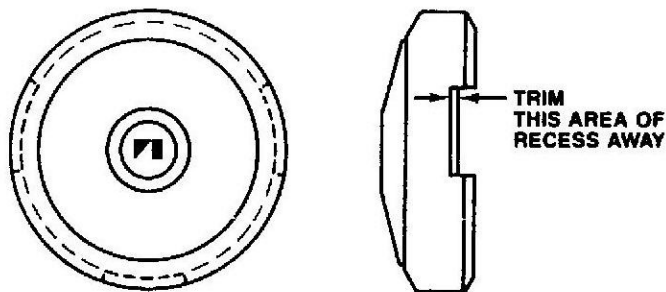
Center Horn Button Cap Spoke  
Recess Modification

3. Remove the center horn button cap.
  - a. If the horn did not operate at one or more of the spoke positions, deepen the spoke recess areas in the cap using a file or knife (see illustration). Trim the recess area down to the cap inner support only.
  - b. Inspect the horn button cap receiver for being bent or warped, especially around the retaining lip. If the receiver is damaged or if the cap was loose, replace the receiver as outlined in the following steps. If the receiver is not damaged and the cap was tight, proceed to step 7.
4. Disconnect the battery negative cable.
5. Remove the three screws that attach the center horn button receiver to the steering wheel hub and remove the receiver bushing and receiver.
6. Position replacement receiver 3242217 in the steering wheel hub and install the bushing and receiver attaching screws.

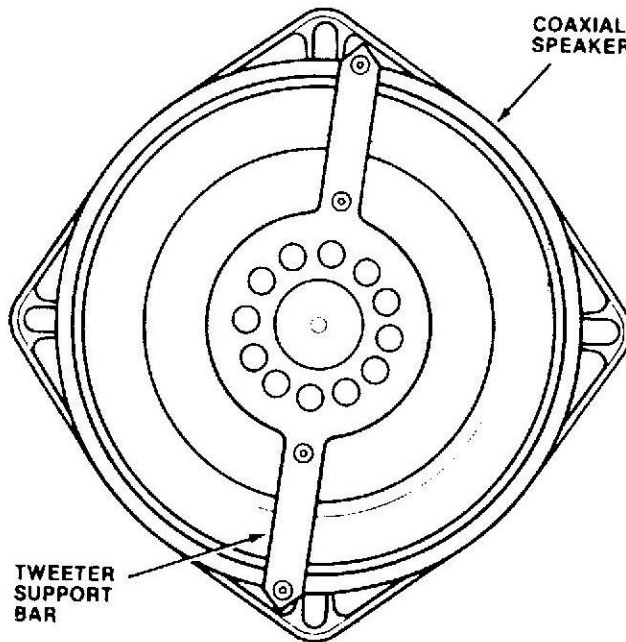
**Coaxial Speaker Identification**

- (2) Replace any speaker that does not have a tweeter support bar mounted across the top of the speaker (see illustration). Coaxial speakers have a support bar, standard speakers do not.
- (3) Verify proper radio operation after speaker replacement.

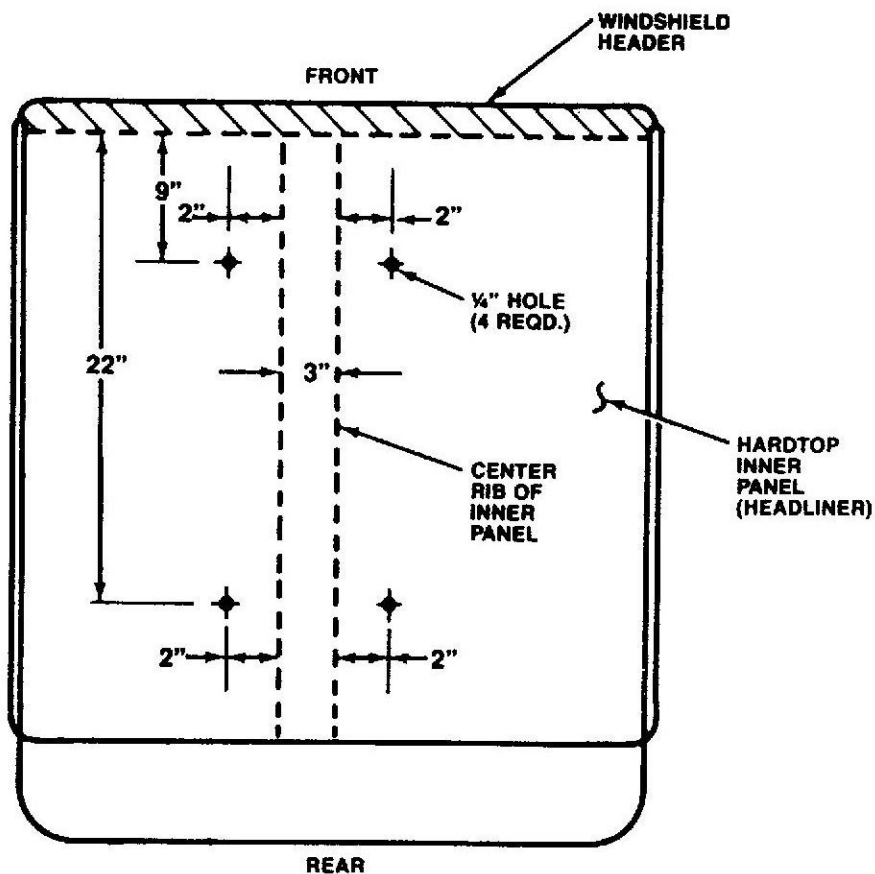
Spray Foam Hole Locations in Hardtop Inner Panel (Headliner) — Viewed From Passenger Compartment

**CAUTION:** Be very careful to avoid drilling through the outer panel when drilling holes in the inner panel.

2. Attach a three inch long section of 1/4 inch O.D. hose to the hose on the Touch-N-Foam can.
3. Insert the 1/4-inch O.D. hose into each hole drilled in the inner panel and spray foam into each hole for 45 seconds.
4. Install the button plugs in the drilled holes.
5. Allow the foam to cure 12 hours.

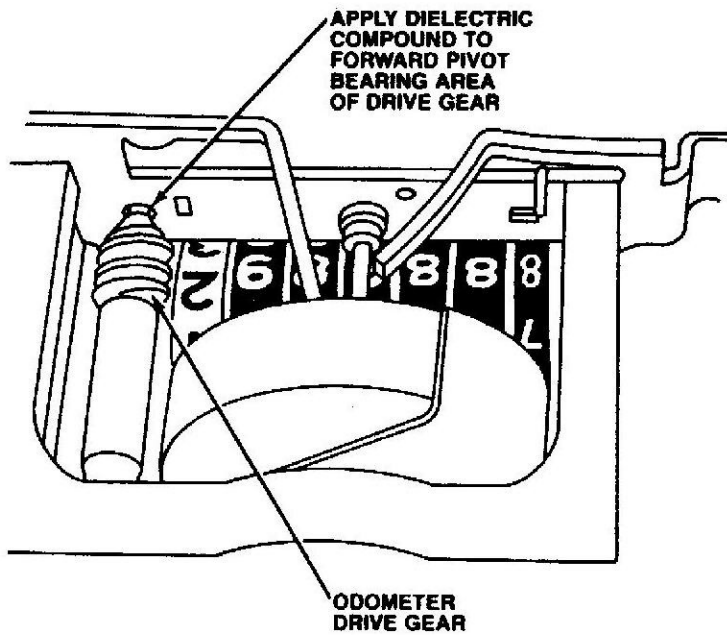
Odometer Drive Gear Lubrication

3. Clean the odometer numeral wheels and speedometer face plate of any traces of compound.
4. Install the speedometer/odometer assembly as outlined in Chapter 3C of the 1981-82 Jeep Technical Service Manuals.
