Diagnosis and Repair Bulletin

Subject: Six-Cylinder Camshaft Pin Breakage

Application: 1977-80 Jeep Vehicles With Six-Cylinder Engines

No. 80-3 Feb. 4, 1980

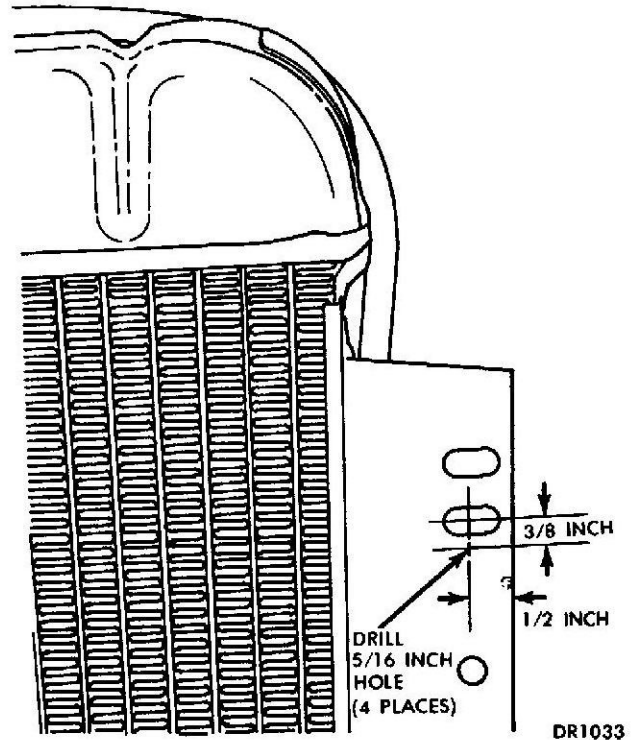
Radiator Mounting Hole Relocation (4 places)

On some 1977 Wagoneer and Cherokee models, with V-8 engine and power steering, the radiator may be positioned too low. Under severe conditions the bottom tank may contact the overcenter adjusting screw and become punctured resulting in a coolant leak.

- (1) Drain radiator coolant.
- (2) Disconnect upper and lower radiator hoses at radiator.
- (3) Remove flexible transmission cooler lines, if equipped.
- (4) Remove radiator and shroud attaching bolts and move shroud back on top of fan.
- (5) Remove radiator. Repair bottom tank if necessary (refer to Radiator Bottom Tank Repair Procedure).
- (6) Measure down 3/8 inch from center of existing mounting holes and centerpunch (see illustration).
- (7) Drill four 5/16 inch holes at positions marked in step (6).
- (8) Position radiator in vehicle, align shroud and install attaching bolts.

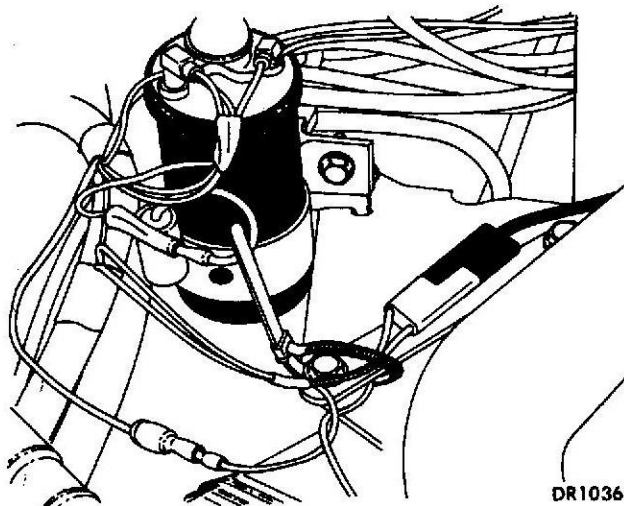
V-8 Distributor Sensor Wire Routing

Before attempting any other diagnosis or repair for ignition system problems, check the sensor wire routing and, if necessary, reroute it. The following illustrations show the most desirable routing for each engine. These routings should be followed whenever the ignition system is being serviced.

NOTE: On V-8 models without air conditioning route sensor wire away from coil wire and plug wires.

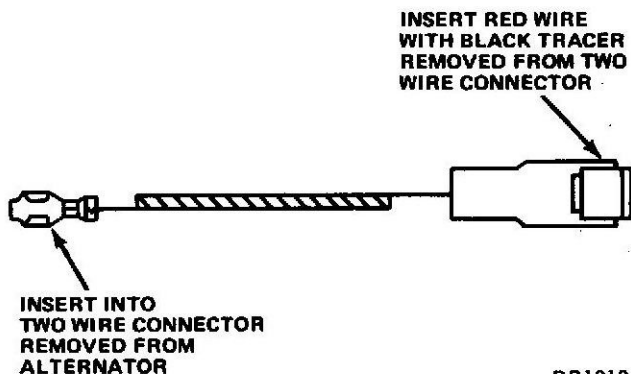
Jumper Wire

On some of the subject 1976 and 1977 CJ models with six-cylinder engines and Delco alternators the engine may continue to run after the ignition switch is turned off. This condition may be caused by alternator feedback.

NOTE: *It may be necessary to bend the locking barb of the terminal so it will engage securely in the jumper wire terminal.*
