11E

APRIL, 1987
ENGLISH EDITION

1986-1987
GRAND WAGONEER/
TRUCK

INTERMITTENT WINDSHIELD WIPERS

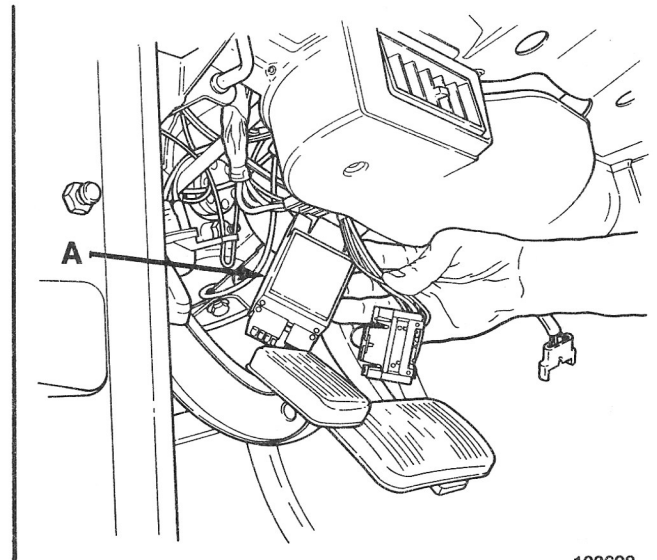
103698

Some 1986 and 1987 Grand Wagoneer/Truck vehicles built before VIN 1JXXXXXXXHTO87763 may have inconsistent intermittent wiper operation.

During high alternator output, such as after starting a cold engine, the intermittent operation of the windshield wipers may become erratic. The timed wiper sweep interval may gradually decrease until there is no pause between sweeps.

Service correction involves replacing the intermittent wiper governor.

1. Locate the intermittent wiper governor (A) under the left side of the instrument panel. Disconnect the connectors on each end of the governor and remove it.
2. Install the two connectors on a new intermittent wiper governor, PN 8956 002 692.
3. Install the new governor under the left side of the instrument panel.
