## I Jeep

## **Diagnosis and Repair Bulletin**

Subject: Carbon Knock

Application: 1980-81 Jeep Vehicles with Four-, Six-, or Eight-Cylinder Engine File: POWER PLANT Engines

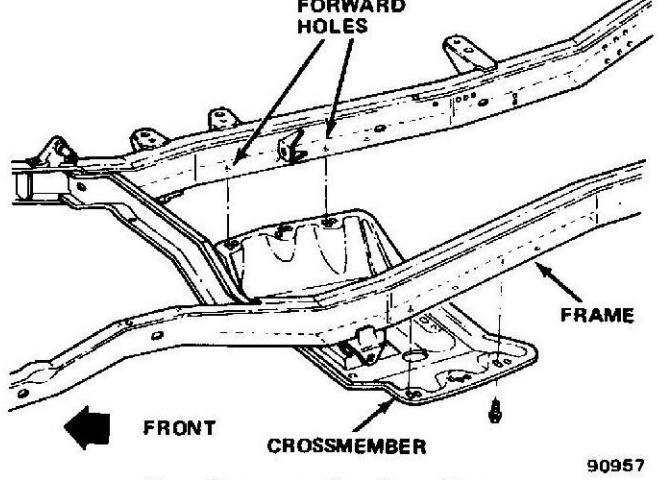
**Rear Crossmember Location**

Some 1980 CJ-7 four-cylinder equipped vehicles built between VIN J0M93XX009040 and J0M93XX014233 were assembled with the torque reaction bracket installed in the rear (towards the rear of the vehicle) set of holes in the transmission-to-transfer case adapter and the rear crossmember positioned incorrectly. This combination results in a noise being caused by contact between the transfer case and the rear crossmember reinforcement.

forward hole in frame (see illustration). Install rear engine mount nuts loosely to hold crossmember in place while crossmember bolts are installed. Tighten crossmember bolts to 30 foot-pounds (41 N·m) torque.

(7) Align forward slot in rear crossmember over

(8) Tighten rear engine mount nuts to 40 footpounds (54 N·m) torque. Install and tighten torque reaction bracket stud nut to 25 foot-pounds (34 N·m) torque.

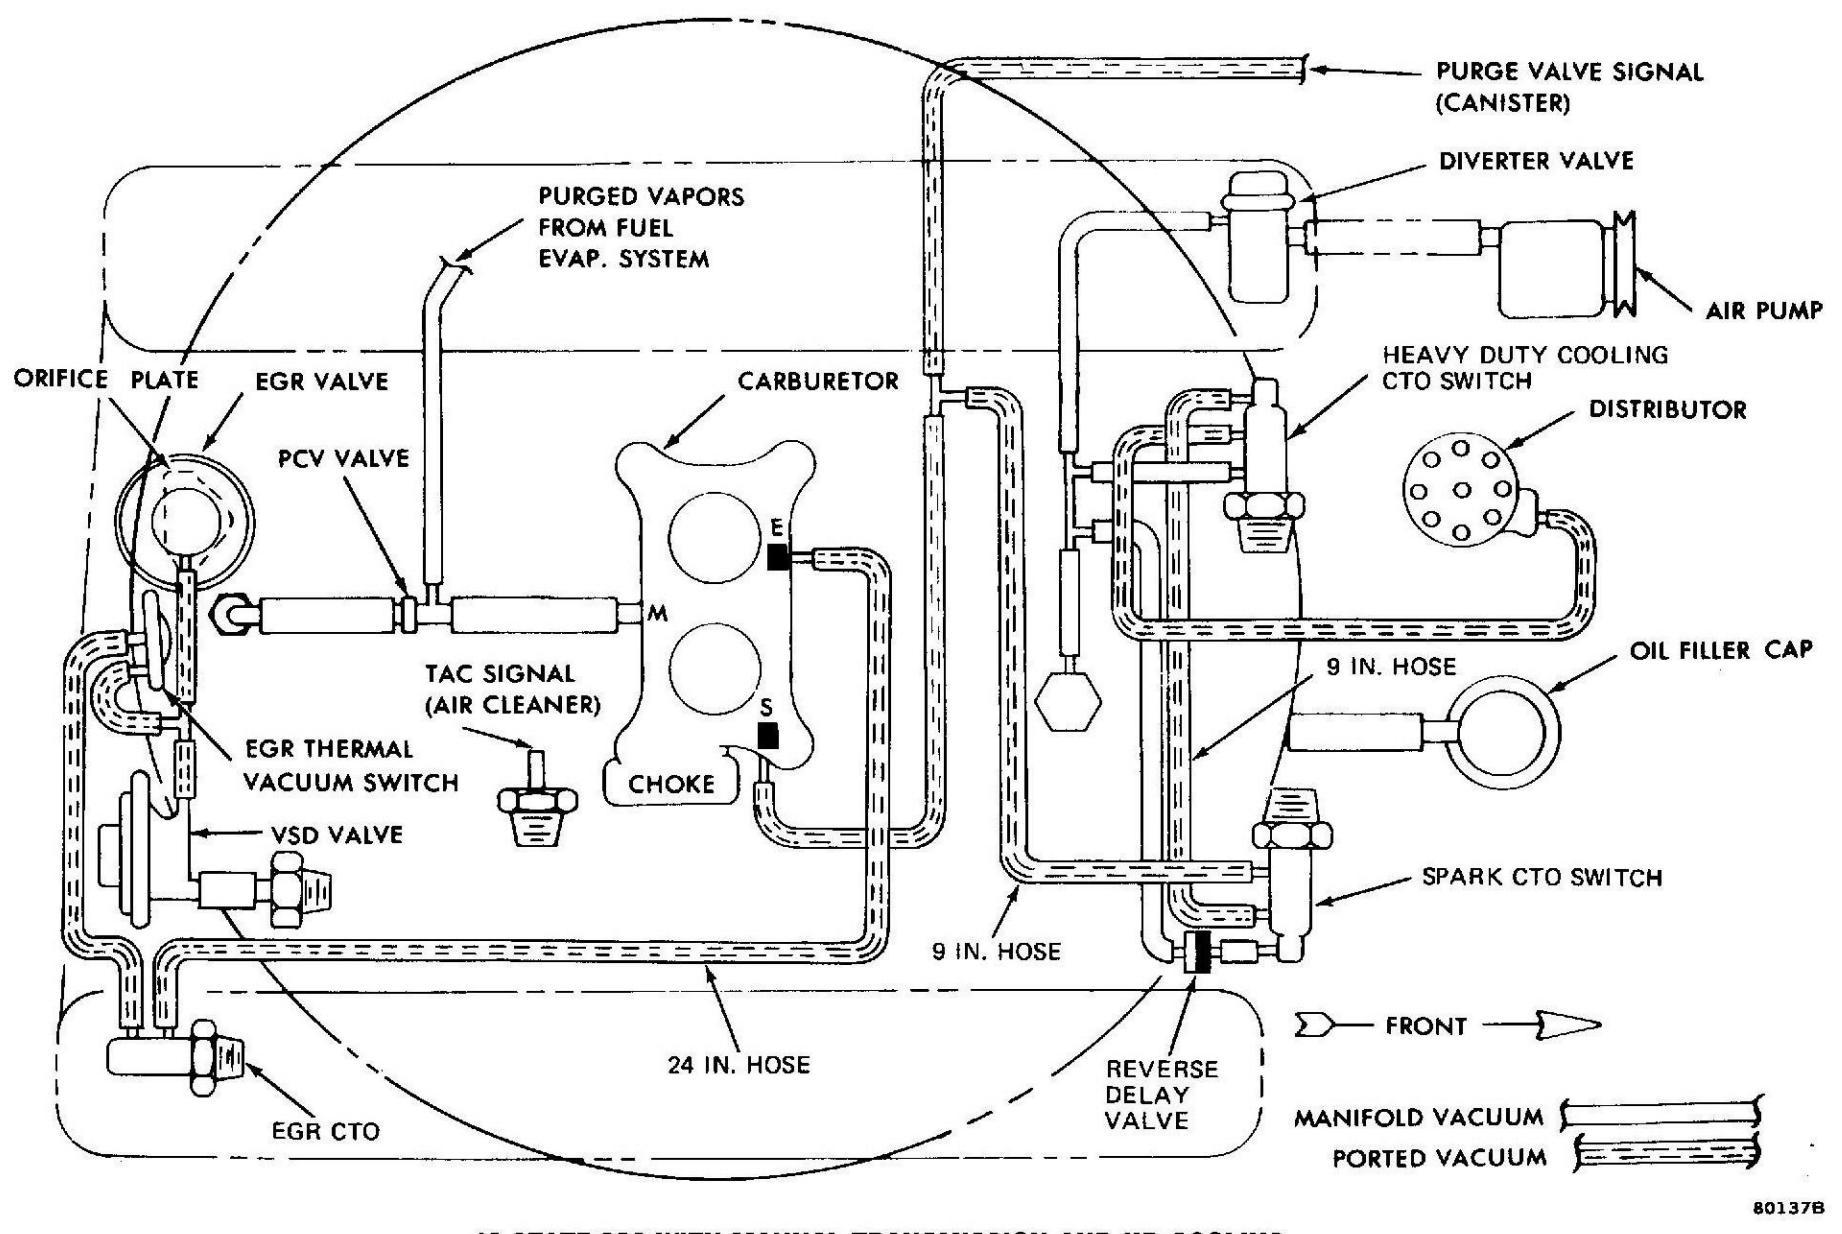
49 STATE 360 WITH MANUAL TRANSMISSION AND HD COOLING

The vacuum diagram on page V-23 of the 1980 Jeep Technical Service Manual is incorrect. The diagram is for 49-State Cherokee and J-10 Truck Models equipped with 360 CID eight-cylinder engine, manual transmission, and heavy duty cooling. Please correct your manual by moistening and affixing the attached correction diagram over the existing diagram on page V-23.

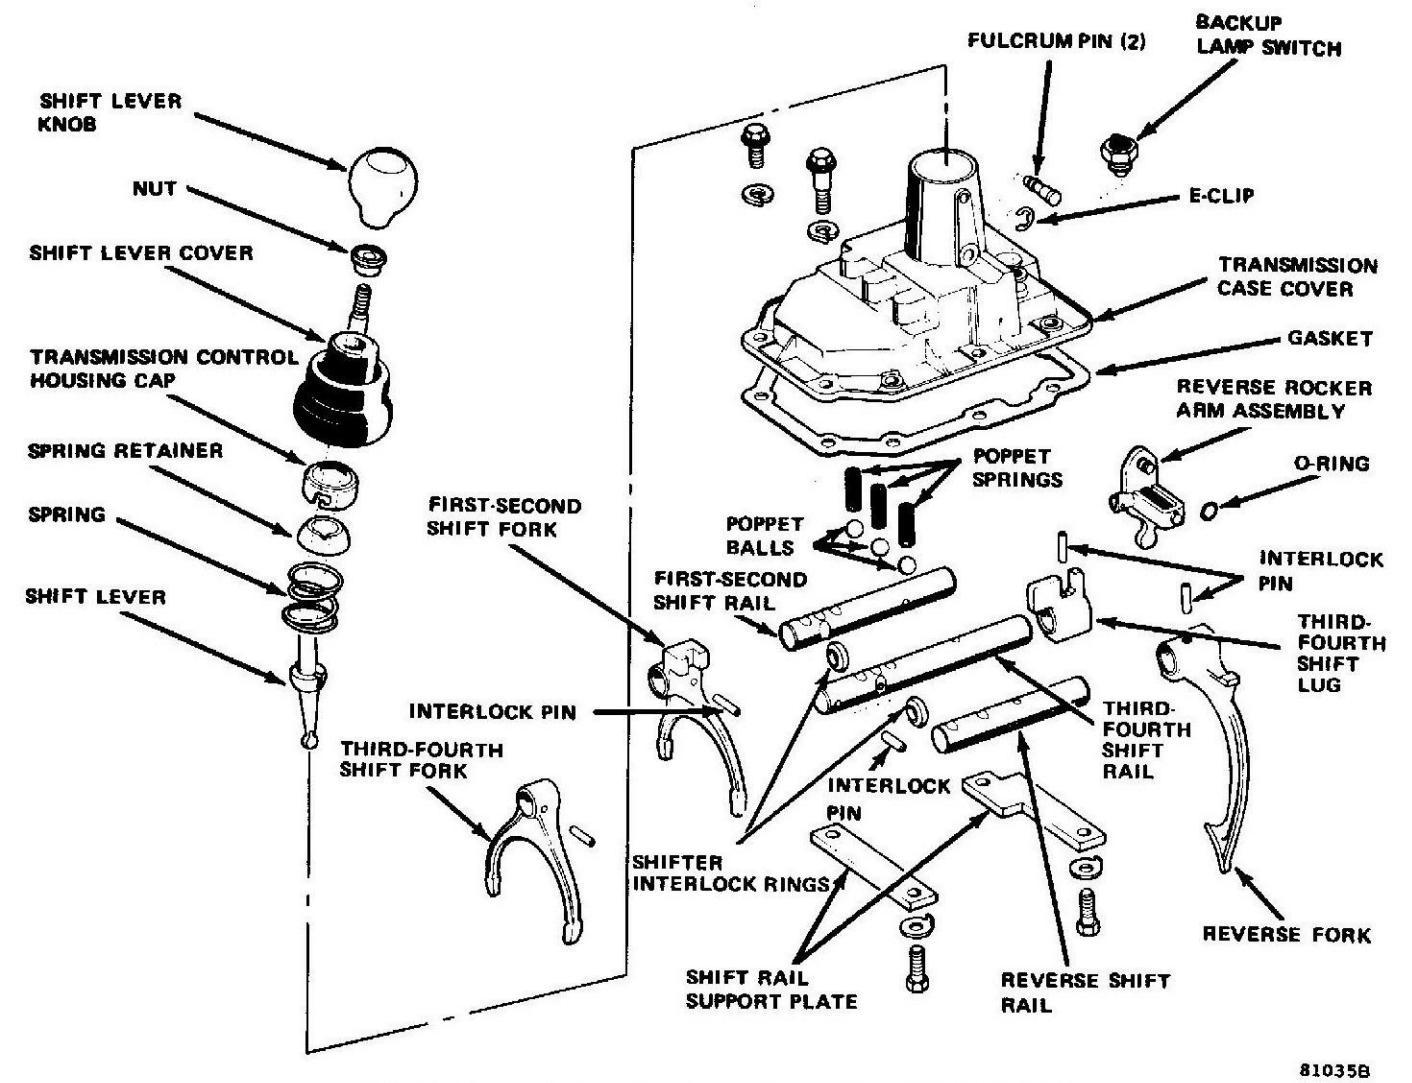
Fig. 1 Transmission Case Cover Assembly – Model T-176

Some early production T-176 4-speed manual transmissions used in the subject models may develop shifting problems such as high shift effort, loose shifting, or the transmission locks in two gears at once preventing vehicle movement with the clutch engaged. These conditions may be the result of loose transmission case cover shift lever fulcrum pins, a damaged reverse rocker arm assembly, missing poppet balls, springs, or interlock rings or burrs on the edges of the shift lever pivot ball.

Service correction involves replacing the transmission case cover and any missing poppet balls, springs and interlocks, and chamfering rough edges on the shift lever pivot ball if necessary.

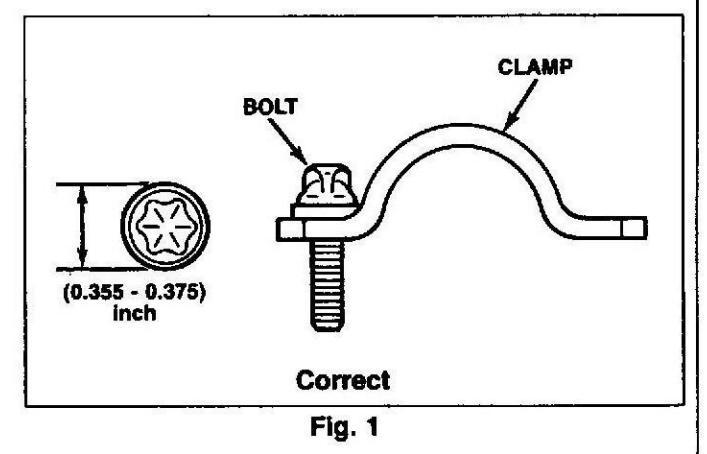
If all bolt heads have small flange (Fig. 1) and there is no interference with clamp, clean yoke using wire brush and shop cloth with solvent. Color every yoke with dab of light colored paint where screws and clamps were correct to note campaign completion, and return vehicle to owner.

If any bolt heads have large flange (Fig. 2), then clamp and bolts must be replaced. Refer to the Replacement Procedure.
