Jeep

Grand Wagoneer/ Truck

**1985 GRAND WAGONEER
WITH 4.2L 6-CYL.**

HEATER CORE COOLANT HOSES

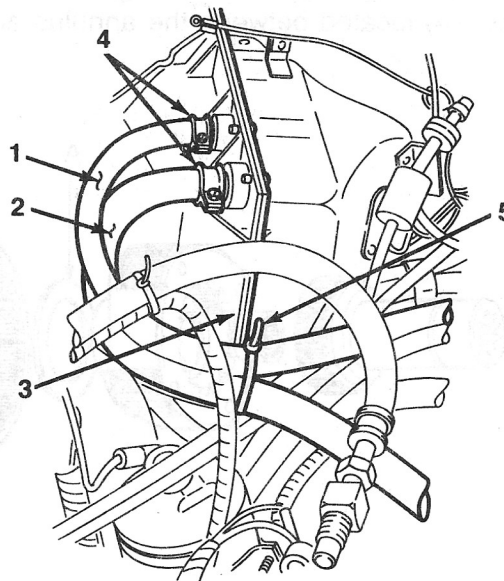
The heater core coolant hoses on some 1985 Grand Wagoneer vehicles equipped with 4.2L 6-Cyl. engines may contact the heater core housing in the engine compartment.

1. Inspect the routings of the heater core coolant hoses at the heater core housing (3) of the engine compartment.
2. If the heater core coolant hoses are not contacting the heater core housing return vehicle to stock/owner. If either heater core coolant hose is contacting the heater core housing, proceed to Step 3.
3. Loosen the heater core coolant hose clamps (4) at the heater core. Rotate the hoses counter-clockwise to reposition the hoses away from the edge (3) of the heater core housing.
4. Retighten the heater core coolant hose clamps.

5. Tie both of the heater core coolant hoses (1, 2) together using a tie strap (5), P/N 322 3227, or equivalent.

Reroute the hoses as described in the following procedure.

6. Start the engine and let it warm to operating temperature.

7. Check the heater core coolant hose system for coolant leaks.
