Diagnosis and Repair Bulletin

**Subject: Six-Cylinder Camshaft
Pin Breakage**

**Application: 1977-80 Jeep Vehicles
With Six-Cylinder Engines**

No. 80-3 Feb. 4, 1980

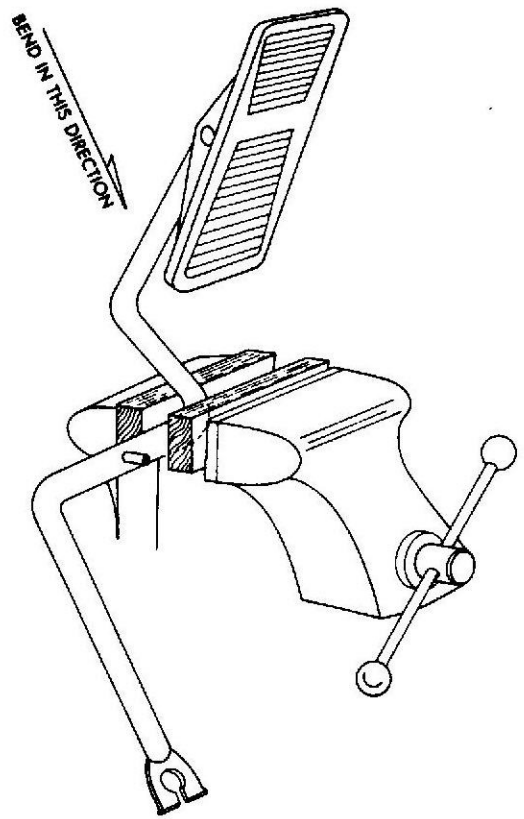
Fig. 4

Some owners of 1978 Wagoneer, Cherokee, and Truck models may find it difficult to obtain wide open throttle or release the choke by depressing the throttle pedal. This may be the result of inadequate throttle travel.

(7) Bend accelerator bellcrank as shown in figure 4, distance recorded in step (2).

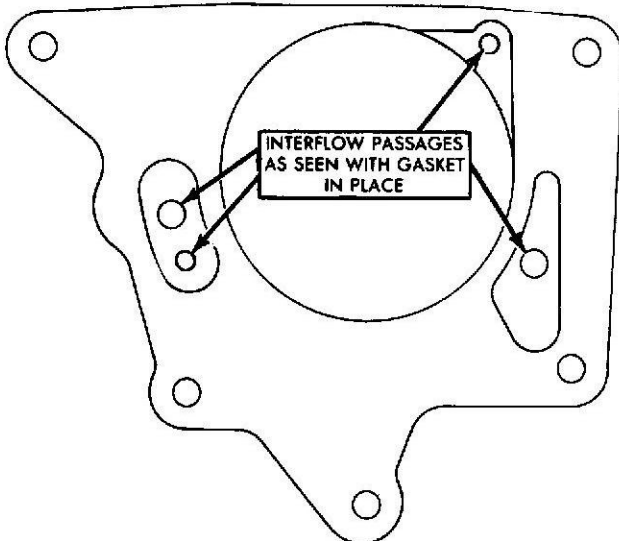
Fig. 1 Tremac 3-Speed Manual Housing With Interflow Lubrication System

- Four holes have been added to the rear face of the transmission case for venting and oil circulation between the transmission and transfer case (Fig. 1).
- The transmission to transfer case gasket has been redesigned as shown (Fig. 1).
- The transmission adapter plate seal has been eliminated.
- The rear oil slinger has been relocated to a position in front of the rear ball bearing (Fig. 2).

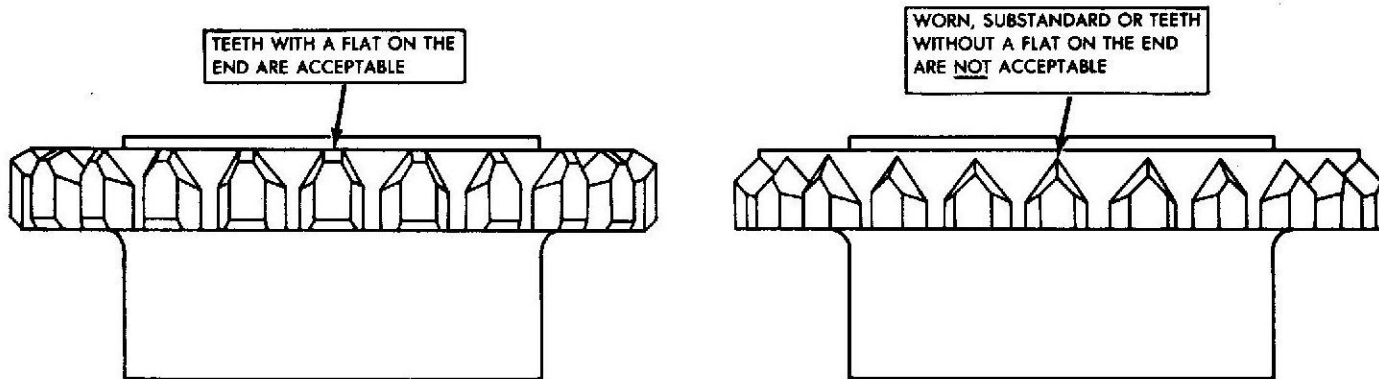
Fig. 1 Direct Drive Sleeve

NOTE: To insure that the new direct drive sleeve will improve the condition compare it with Fig. 1.

- (9) Install direct drive sleeve.

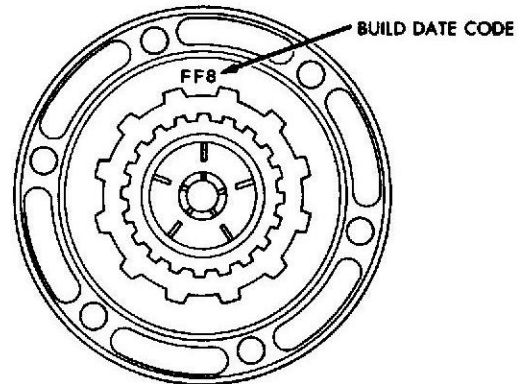
Hub Build Date Code Location

If the hubs were built prior to date code FF8 and hub internal parts are rusty, replace the hubs as a set. If the hubs were built on or after date code FF8 and do not exhibit signs of rust, reinstall the hub covers; then refer to Driveline Vibration, Page 2E-3, Volume 2 of the 1978 Jeep Technical Service Manual.

NOTE: Do not attempt to clean and lubricate rusty hubs; replace the hubs as a set only.

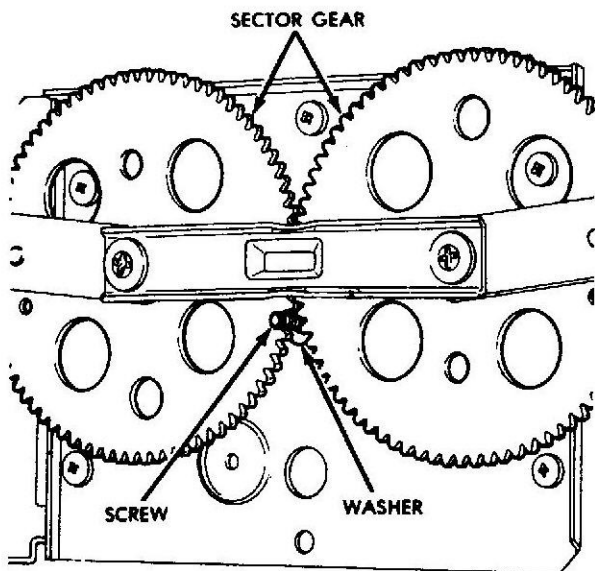
Fig. 1 Locking Electric Operated Window Regulator Gears

If the electrically operated tailgate window, on one of the above vehicles, is inoperative and the problem is caused as a result of a loose pinion gear shaft on the window regulator, it is no longer necessary to replace the window regulator.

- (7) Install a 1/4 inch by 1 inch screw, with flat washer, between the sector gear teeth (Fig. 1).
- (8) Remove motor attaching screws and slide motor from under regulator.
- (9) Remove regulator attaching screw and regulator. If attaching screws are not accessible, proceed as follows:
 - (a) Grasp regulator arm as far outboard as possible.
 - (b) Push downward on arm until sector gear holes align with attaching screw.
 - (c) Hold regulator arm down and insert screw between sector gear teeth.
 - (d) Remove regulator attaching screws and regulator.
- (10) Clean regulator in solvent and dry with compressed air.
- (11) Wire brush area around pinion gear shaft.
- (12) Stake pinion gear shaft in position.
- (13) Tack weld pinion gear shaft in three places (Fig. 2).

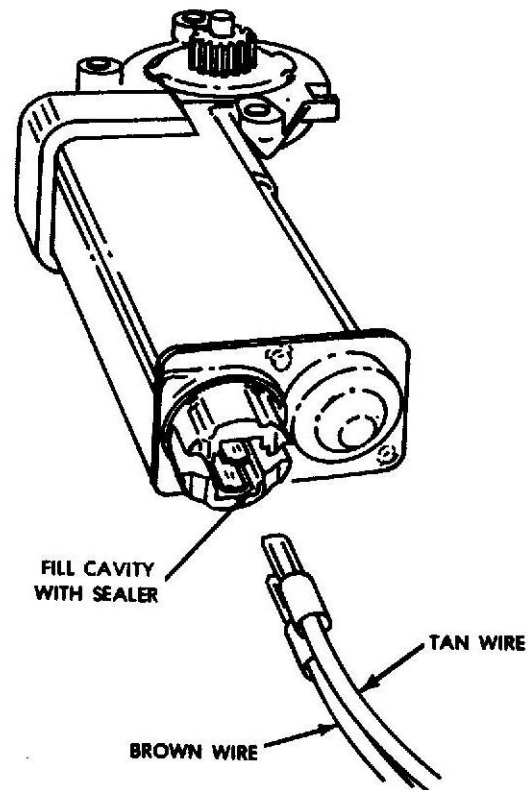
Electric Tailgate Window Motor

If the electrically operated tailgate window, on one of the above vehicles, is inoperative and the problem is caused as a result of a broken electrical connector on the motor, it is no longer necessary to replace the motor.

Effective repairs can be made by cutting the female connector from the wires, installing two quick connect terminals, and filling the connector cavity on the motor with a sealer. The following parts will be required.

- (1) Lower tailgate window.
- (2) Open tailgate.
- (3) Remove tailgate carpet and access cover.
- (4) Raise tailgate window, using safety switch.
- (5) Loosen window regulator screw.
- (6) Remove motor from window regulator.
- (7) Disconnect female connector from motor.
- (8) Cut off wires at female connector.
- (9) Strip ends of both wires.
- (10) Attach 1/4 inch quick connect female terminal to each wire.
- (11) Connect tan wire to upper motor terminal (see illustration).
- (12) Connect brown wire to lower motor terminal (see illustration).

- (13) Fill motor connector cavity with Gasket-in-a-Tube Sealer, part number 8993317, or equivalent (see illustration).
- (14) Install motor on window regulator.
- (15) Tighten window regulator screw.
- (16) Install tailgate access cover and carpet.
- (17) Lower tailgate window, using safety switch.
- (18) Close tailgate.
- (19) Check tailgate window for proper operation.

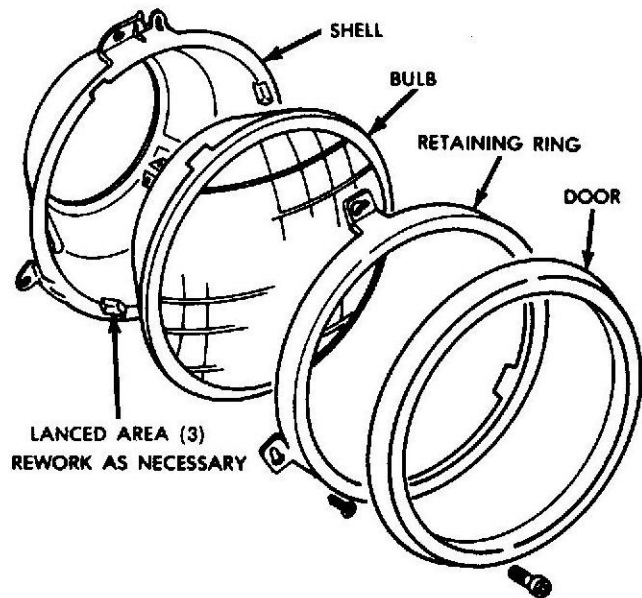
If a sealed beam headlamp unit is reported to be cracked on a CJ-5 or CJ-7, built between the above VINs check to be sure that the lamp was positioned in the shell properly. When replacing the unit, make sure that the shell lances align properly with the bosses on the lamp. If an interference between one of the shell lances and the lamp bosses is encountered, correct the condition as outlined in the following procedure.

- (1) Remove headlamp door.
- (2) Remove headlamp retaining ring.
- (3) Remove and discard cracked bulb.
- (4) Position replacement bulb in shell and check for proper alignment.
- (5) File lanced area of shell that interferes with bosses of bulb (see illustration).
- (6) Install headlamp bulb.
- (7) Install headlamp retaining ring.
