Diagnosis and Repair Bulletin

Subject: Six-Cylinder Camshaft Pin Breakage

Application: 1977-80 Jeep Vehicles With Six-Cylinder Engines

No. 80-3 Feb. 4, 1980

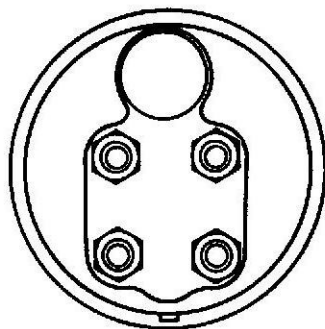
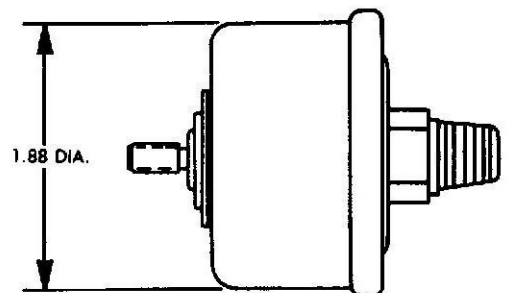
Fig. 1 Stewart-Warner Oil Pressure Gauge and Sending Unit

If it becomes necessary to replace a gauge and sending unit, be sure they are replaced as a matched set only. Part numbers for the gauges and sending units are as follows:

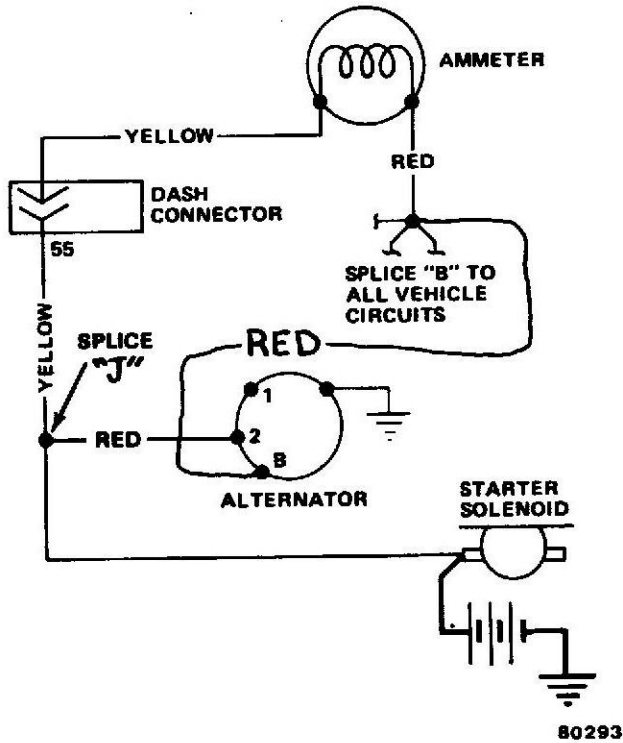
Fig. 1 Ammeter Circuit — Cherokee - Wagoneer - Truck Models

This bulletin is being issued to revise the ammeter circuit illustration for Cherokee, Wagoneer, and Truck models on page 1L-43, Volume I of the 1978 Technical Service Manual and on page 1L-45 of the 1979 Technical Service Manual. The revised circuit illustration is shown in figure 1. In addition, the wiring diagram for Cherokee, Wagoneer, and Truck models on page W-5 in the 1979 Technical Service Manual has also been revised to identify splice "B" as shown in figure 2.

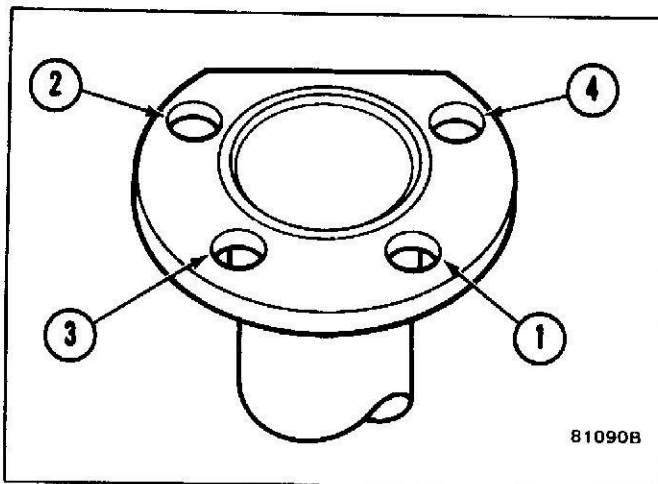
Fig. 5 Axle Tube Flange Bolt and Nut Tightening Sequence

CAUTION: This procedure is necessary to ensure that the seal and bearing cup rib ring are seated squarely in the axle tube. The seal can be damaged if this procedure is not followed.

(5) Tighten all nuts alternately and evenly in a cross pattern (Fig. 5) to approximately 15 foot-pounds (20 N.m.) torque to seal and cup rib ring evenly in axle tube.

(6) Tighten nuts to final torque of 50 foot-pounds (68 N.m) torque in a cross pattern (Fig. 5).

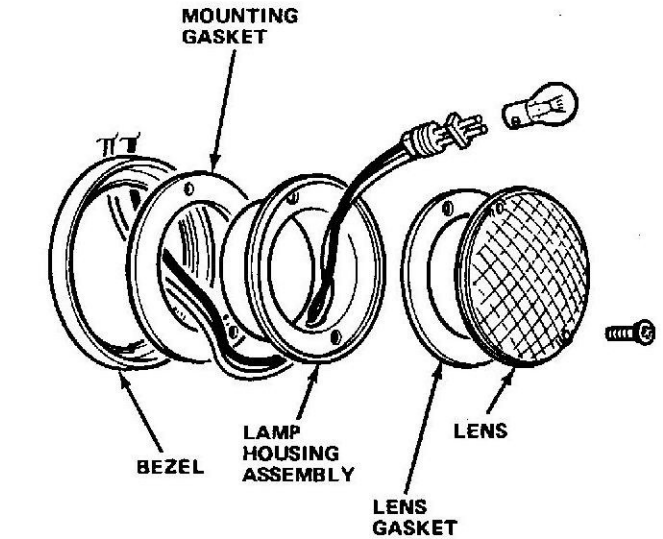
Lamp Assembly and Gaskets

- (1) Remove park and turn signal lamp assemblies from grille panel and inspect mounting gasket for any distortion. Replace gasket if distorted.
- (2) Inspect internal bulb sockets for corrosion.
 - (a) If corrosion is not present, then continue procedure on existing assemblies.
 - (b) If corrosion is present, obtain replacement lamp and continue procedure.
- (3) Apply chassis lubricant or dielectric compound, 8127445, to bulb socket to prevent corrosion.

- (4) Remove two screws that attach lens and gasket to lamp housing. Separate lens from lamp housing and gasket. Rotate housing and gaskets 180° so wires exit from bottom of housing and assemble lens to housing (see illustration).
- (5) Install assembly (with new mounting gasket if required) to grille panel being careful not to strip screws.
