FILE: Engines-Fuel Systems  
Engine Electrical-Cooling  
(POWER PLANT-Engines)  
No. 1-10-82 Sept. 8, 1982

## TECHNICAL BULLETIN

# Diagnosis and Repair Bulletin

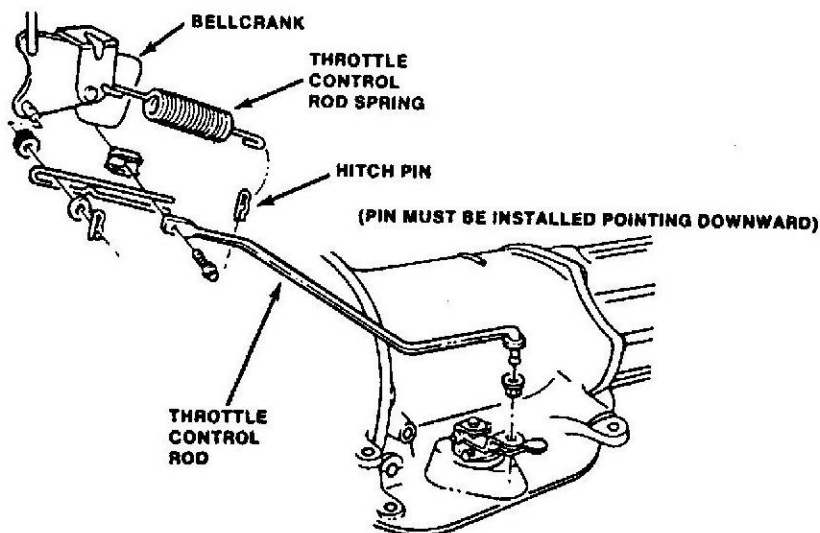
Figure 1 - Throttle Control Rod Spring Position

On some 1981 Jeep CJ7, Cherokee, Wagoneer and Truck models with six-cylinder engines and automatic transmissions, the automatic transmission throttle control rod spring and spring hitch pin may be improperly installed causing the throttle to close slower than expected. This condition could result in longer stopping distances or higher than normal braking effort.

- (1) Open hood and inspect throttle control rod spring position.
- (2) If spring is attached to bellcrank and to hitch pin, as shown in Figure 1, spring is correctly installed. Proceed to Step (4).
- (3) If spring is incorrectly attached at either the bellcrank or the hitch pin, correct, as shown in Figure 1, and check throttle linkage operation.
- (4) Place yellow paint mark on bellcrank to indicate completion of campaign inspection/repair procedure.
- (5) Close hood and return vehicle to owner.
