FILE: Engines-Fuel  
Systems-Engine Electrical-  
Cooling (POWER PLANT-  
Engine Electrical)  
No. 1-13-82 Nov. 11, 1982

## TECHNICAL BULLETIN

An inoperative Cruise Command servo on 1981-82 Jeep vehicles may be due to a cracked or broken manifold vacuum hose connector on the servo.

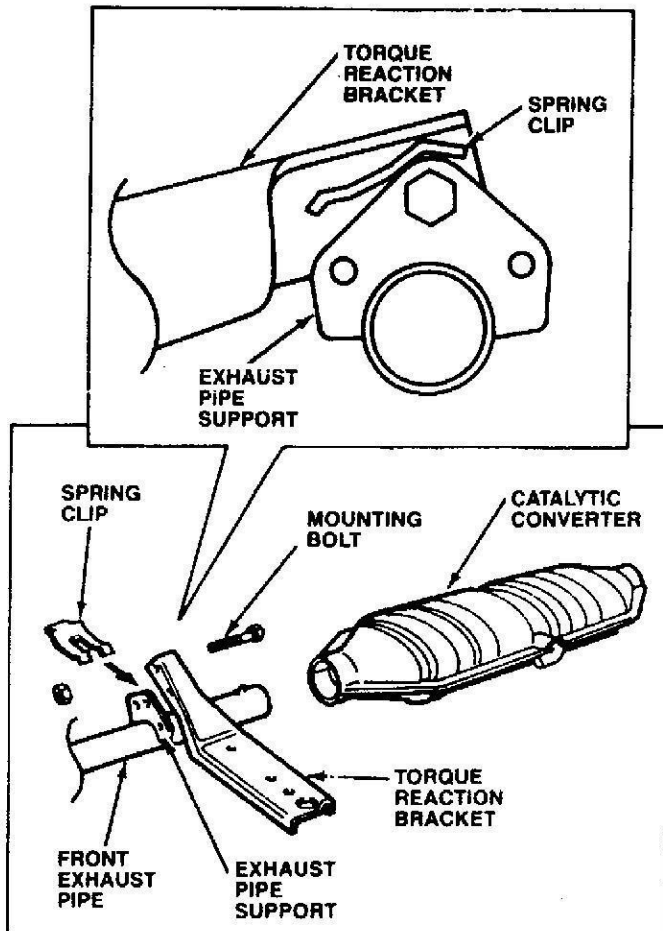
**PROBLEM AND APPLICATION:** The exhaust manifold to front exhaust pipe stud nuts on 1982 Jeep four-cylinder engines built prior to February 1982, may loosen causing an exhaust noise.

5. Install the locknut on the exhaust pipe mounting bolt and tighten the bolt and nut to 18 foot-pounds (24 N.m) torque.

**CORRECTION:** Replace the original exhaust manifold to front exhaust pipe studs and nuts with the locking-type studs, stud nuts, and hardened washers used on 1982 six-cylinder engines.

1. Raise and support the vehicle.
  2. Disconnect the front exhaust pipe from the exhaust manifold.
  3. Remove the studs from the exhaust manifold with vise grip pliers.
- NOTE: It may be necessary to apply heat to the exhaust manifold in order to remove the studs.
4. Install the replacement locking-type studs in the exhaust manifold.
  5. Position the front exhaust pipe on the exhaust manifold studs and install the replacement washers and nuts. Tighten the nuts to 23 foot-pounds (31 N·m) torque.
  6. Remove the supports and lower the vehicle.
