Diagnosis and Repair Bulletin

Subject: Six-Cylinder Camshaft Pin Breakage

Application: 1977-80 Jeep Vehicles With Six-Cylinder Engines

No. 80-3 Feb. 4, 1980

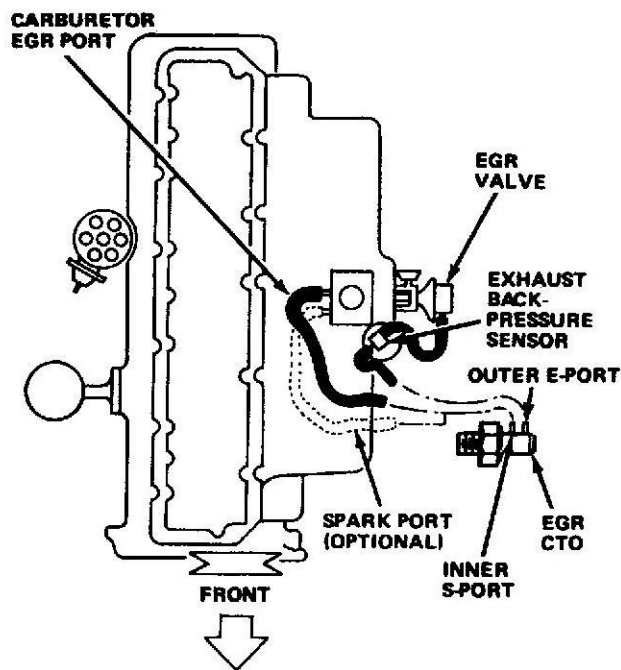
Vacuum Hose Routing for 6-Cylinder 42014

Some 1974-1979 Jeep vehicles have defective exhaust gas recirculation (EGR) back-pressure sensor valves. (Refer to Jeep Application Chart for model year and engine displacement.) Service correction involves replacing the EGR back-pressure sensor with a newly designed sensor (regardless of sensor's present condition), performing an idle mixture adjustment on all 6-cylinder engines, and affixing a Campaign Label (8-cylinder) or a combined Campaign and 6-cylinder Lean

- 12) On 6-cylinder vehicles:
 - a) Readjust idle mixture setting by idle drop method (new specification is 50 RPM on all 6-cylinder engines). Refer to appropriate Technical Service Manual for idle drop procedure.
 - b) Install blue limiter cap(s) after 6-cylinder idle mixture adjustment.
 - c) Affix combined Campaign Label and 6-Cylinder Lean Idle Drop Emissions Control Information Label beside present underhood maintenance label (See Figure 2-a).

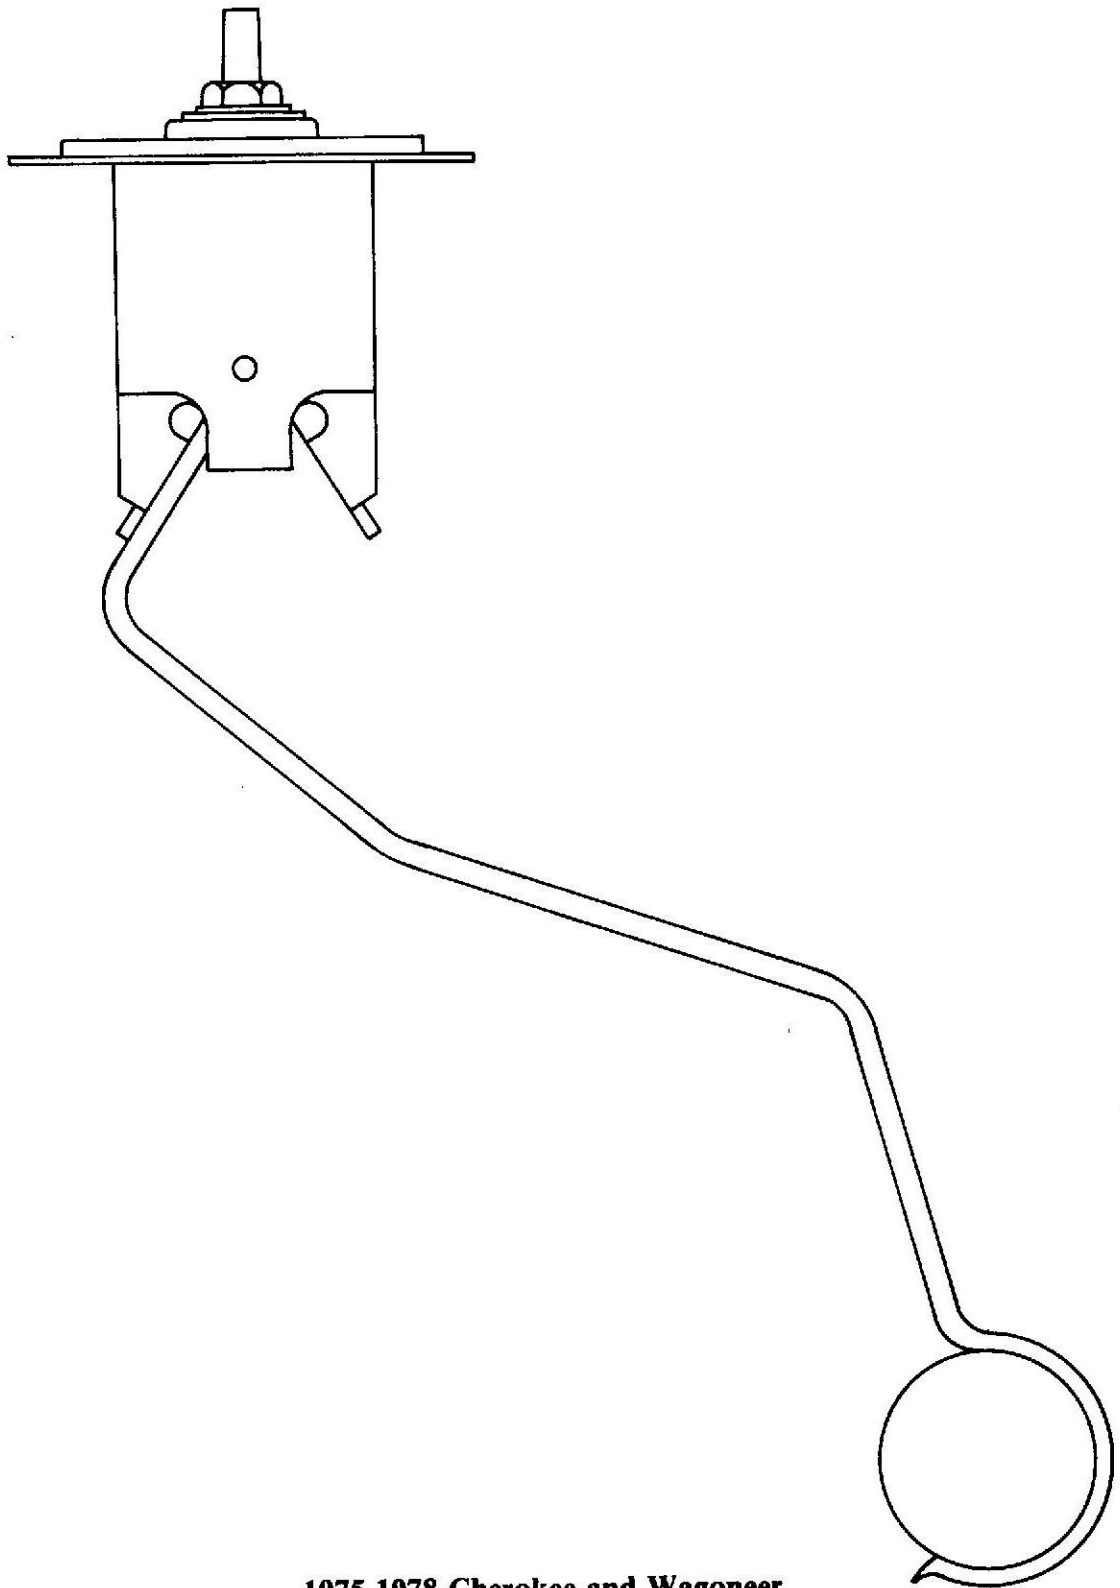
**1975-1978 Cherokee and Wagoneer
Sending Unit Template**

The fuel gauge in some 1975-1978 Cherokees and Wagoneers may indicate 3/4 full when the tank is known to be full. This condition may be the result of inaccuracy in the fuel tank sending unit.

- (1) Remove fuel tank, as described in appropriate Technical Service Manual.
- (2) Remove sending unit.
- (3) Check sending unit with an ohmmeter for continuity through resistor for normal resistance change as lever is moved through its full arc of travel.
 - (a) If sending unit is electrically faulty, replace it.
 - (b) If sending unit is electrically sound, proceed to step (4).
- (4) Reshape sending unit lever to attached template.
- (5) Install sending unit in tank.
- (6) Install fuel tank as described in appropriate Technical Service Manual.

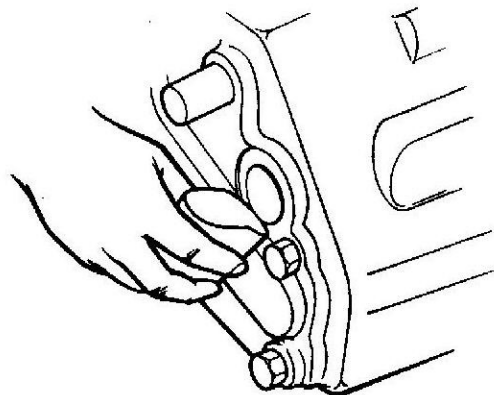
Fig. 1 Collecting Excess Lubricant with Paper Cup.

- (1) Obtain a paper cup and remove lip so excess transfer case lubricant can be caught when fill plug is removed.
- (2) Remove transfer case fill plug and catch all excess oil that flows out filler hole (see fig. 1). Pour excess oil into measuring cup graduated in ounces.

(3) If excess lubricant exceeds four ounces, transmission adapter plate seal replacement is necessary. Refer to the **Transmission Adapter Plate Seal Replacement Procedure** in this Diagnosis and Repair Bulletin.

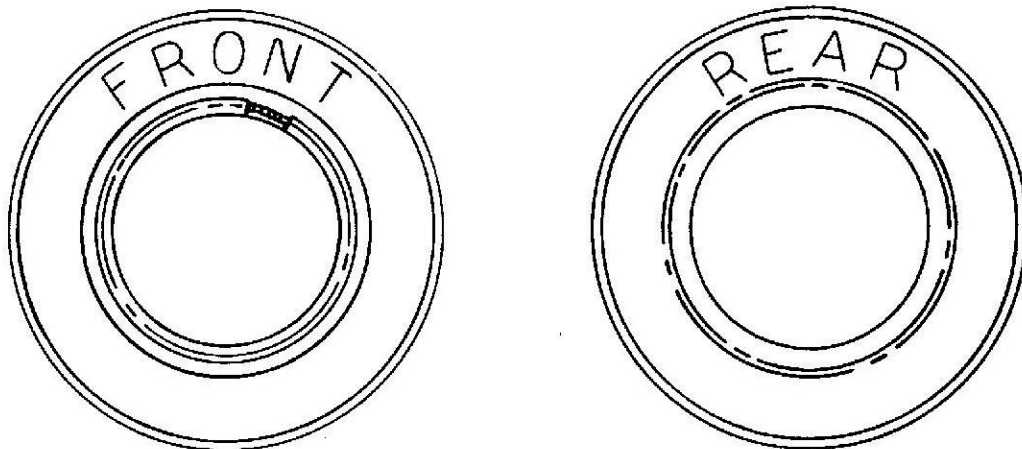
Fig. 3 Adapter Plate Seal.

(21) Slide transfer case mainshaft gear onto mainshaft. Apply hand pressure against gear and check clearance between forward surface of transfer case mainshaft gear and rear face of adapter plate seal. Clearance should be no less than .050" at any point between seal housing and mainshaft gear. If clearance is less than .050" use Installer Tool J-26852 to reseal adapter plate seal and repeat clearance check.

NOTE: *Seal Installer Tool J-26852 must be used to install the adapter plate seal to assure proper alignment and sealing.*

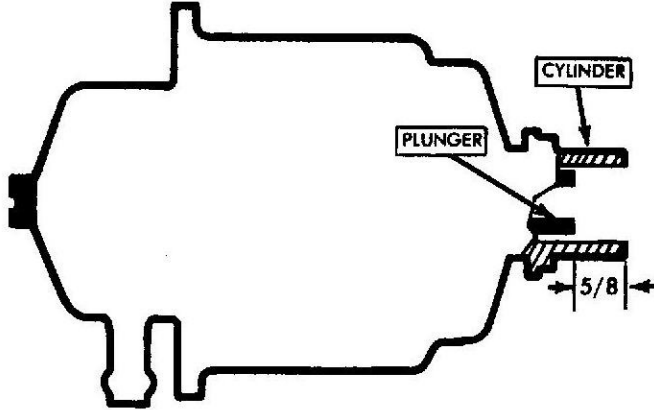
Fig. 2 Vacuum Modulator

(2) Measure distance of plunger travel with maximum vacuum applied. Distance from plunger to edge of cylinder should measure approximately 5/8 inch (see Fig. 2).

NOTE: Maximum applied vacuum should remain constant for at least 30 seconds. If modulator will not hold vacuum as required, replace the modulator.

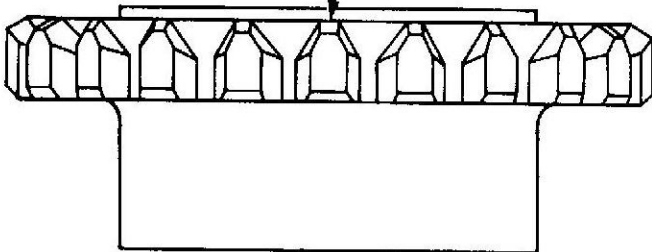
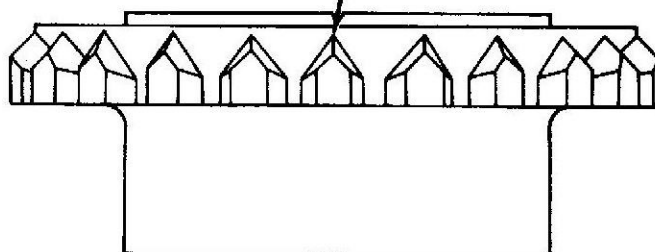
Fig. 1 Direct Drive Sleeve

TEETH WITH A FLAT ON THE END ARE ACCEPTABLE

WORN, SUBSTANDARD OR TEETH WITHOUT A FLAT ON THE END ARE NOT ACCEPTABLE

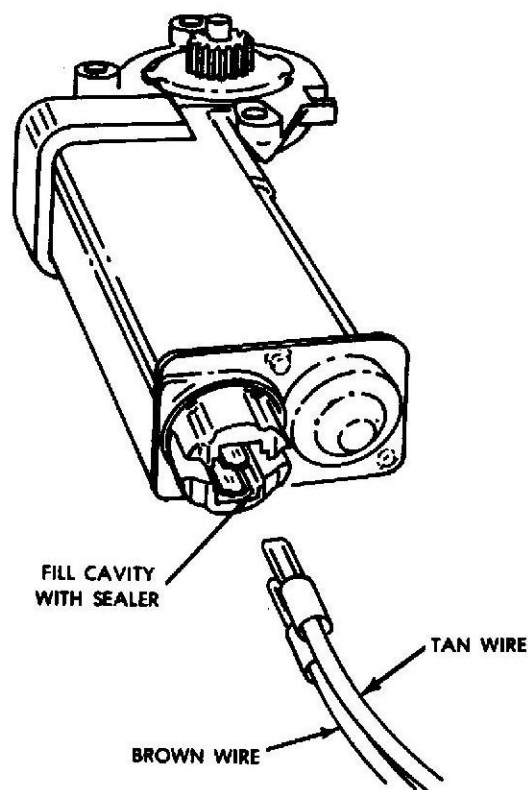
Electric Tailgate Window Motor

If the electrically operated tailgate window, on one of the above vehicles, is inoperative and the problem is caused as a result of a broken electrical connector on the motor, it is no longer necessary to replace the motor.

Effective repairs can be made by cutting the female connector from the wires, installing two quick connect terminals and filling the connector cavity on the motor with a sealer. The following parts will be required.

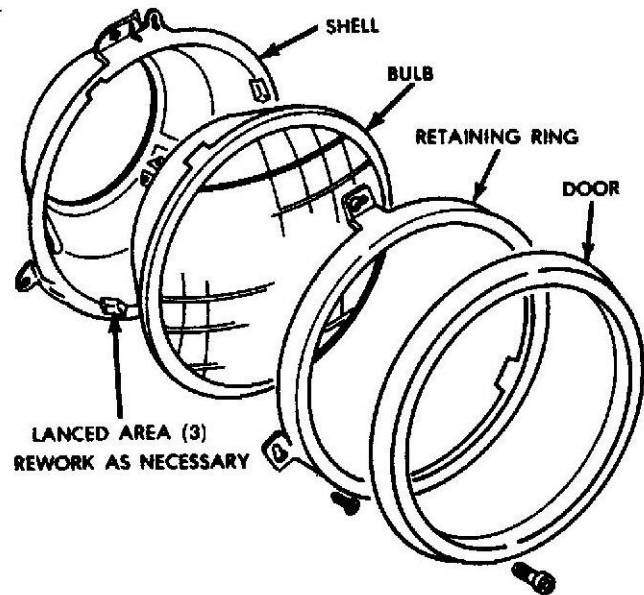
If a sealed beam headlamp unit is reported to be cracked on a CJ-5 or CJ-7, built between the above VINs check to be sure that the lamp was positioned in the shell properly. When replacing the unit, make sure that the shell lances align properly with the bosses on the lamp. If an interference between one of the shell lances and the lamp bosses is encountered, correct the condition as outlined in the following procedure.

- (1) Remove headlamp door.
- (2) Remove headlamp retaining ring.
- (3) Remove and discard cracked bulb.
- (4) Position replacement bulb in shell and check for proper alignment.
- (5) File lanced area of shell that interferes with bosses of bulb (see illustration).
- (6) Install headlamp bulb.
- (7) Install headlamp retaining ring.

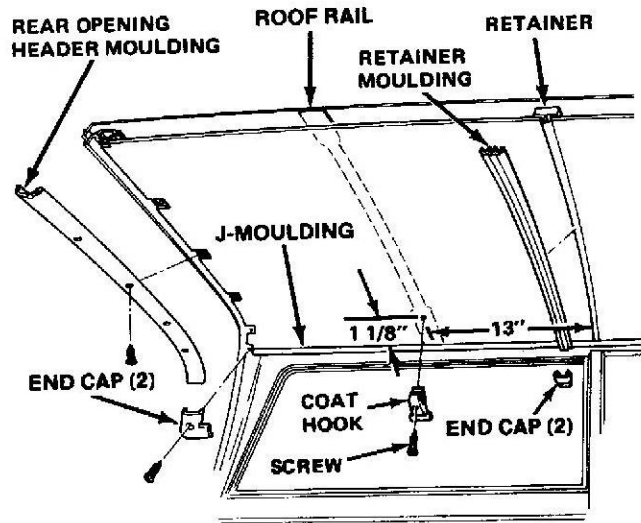
60866

Some owners of 1976 and 1977 Wagoneers and Cherokees may complain of a sag in the rear headlining. This condition is caused by the headlining not fully seating into the retainer mouldings.

Service correction, on a complaint basis, involves repositioning the headlining in the retainer mouldings and installing two coat hooks for additional support. The following parts, as applicable, will be required.
