## I Jeep

## **Diagnosis and Repair Bulletin**

Subject: Carbon Knock

Application: 1980-81 Jeep Vehicles with Four-, Six-, or Eight-Cylinder Engine File: POWER PLANT Engines

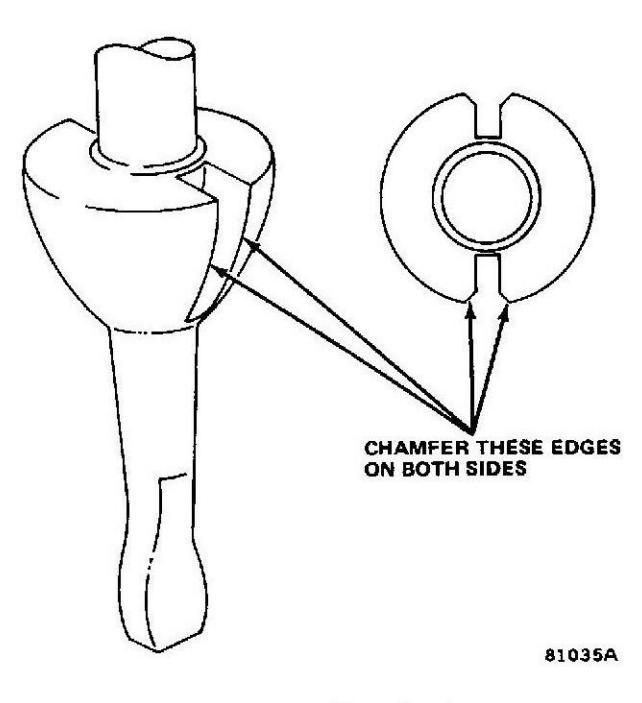
Some early production T-176 4-speed manual transmissions used in the subject models may develop shifting problems such as high shift effort, loose shifting, or the transmission locks in two gears at once preventing vehicle movement with the clutch engaged. These conditions may be the result of loose transmission case cover shift lever fulcrum pins, a damaged reverse rocker arm assembly, missing poppet balls, springs, or interlock rings or burrs on the edges of the shift lever pivot ball.

Service correction involves replacing the transmission case cover and any missing poppet balls, springs and interlocks, and chamfering rough edges on the shift lever pivot ball if necessary.

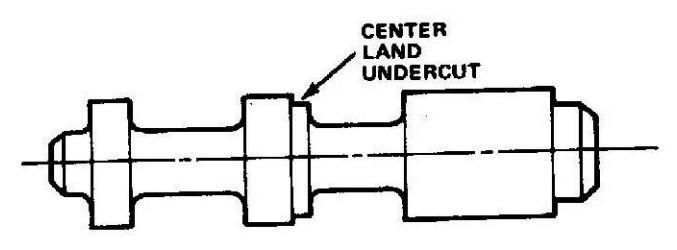
Switch Valve Comparison

On some 1980 CJ models with a model 999 automatic transmission built prior to build date code 6863, the transmission may occasionally produce a moan or buzzing noise when shifted into reverse or when the gearshift selector lever is between the Park and Reverse detents. This condition may be caused by the normal rapid flow of transmission fluid over the finely machined center land of the switch valve in the transmission valve body. On transmissions built after date code 6863, a new switch valve with an undercut center land was phased into production and is now available for service (see illustration). The new valve design eliminates the possibility of any occasional noise caused by normal fluid flow over the center land.

Service correction involves verifying the condition using the diagnosis procedure provided in this bulletin and installing the new switch valve if diagnosis indicates this is necessary.

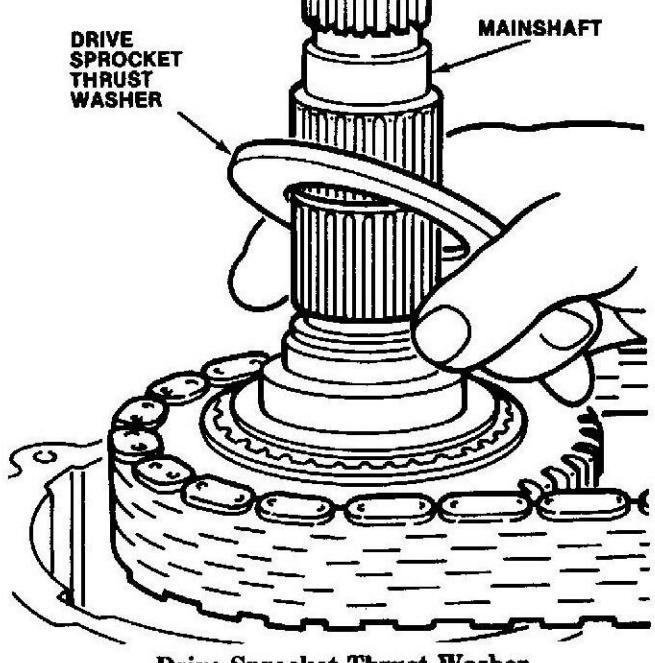
Drive Sprocket Thrust Washer Removal/Installation

On some 1980 Cherokee, Wagoneer, and Truck models with a model 208 transfer case, the transfer case drive sprocket thrust washer inside diameter may have a rough surface finish that could cause a squeal noise to occur occasionally. The noise is most noticeable in the 30-55 mph range and only when the transfer case is in two wheel drive high (2H) position, the front hubs unlocked, and when the transfer case is at normal operating temperature.

- (8) Remove transfer case rear yoke using tools J-8614-01, -02, -03 if necessary.
- (9) Inspect output seal in rear retainer if seal exhibits signs of oil leakage, remove and discard seal.
- (10) Remove speedometer driven gear and sleeve from rear retainer.
- (11) Mark rear retainer for assembly alignment reference and remove retainer attaching bolts. Tap retainer with rubber mallet to loosen it and remove retainer.
- (12) Remove pump housing.
- (13) Remove speedometer gear.
- (14) Remove oil pump.
- (15) Remove drive sprocket retaining ring.
- (16) Remove and discard drive sprocket thrust washer (see illustration).

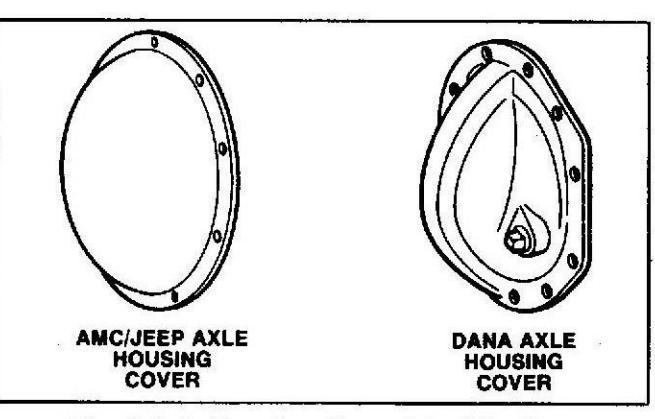
Fig. 1 Axle Housing Cover Identification

(b) If axle has oval, irregular shaped cover (Fig. 1), vehicle has Dana axle and does not require any repairs.

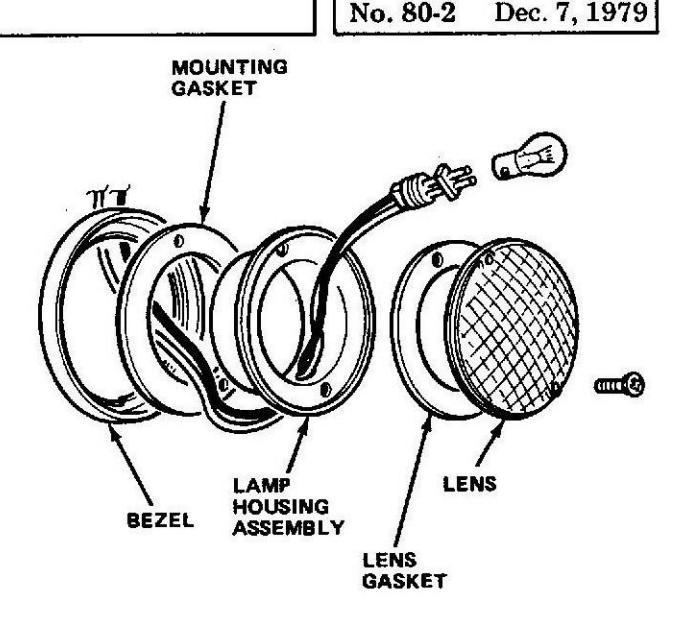
Lamp Assembly and Gaskets

(b) If corrosion is present, obtain replacement lamp and continue procedure.

(3) Apply chassis lubricant or dielectric compound, 8127445, to bulb socket to prevent corrosion.

(4) Remove two screws that attach lens and gasket to lamp housing. Separate lens from lamp housing and gasket. Rotate housing and gaskets 180° so wires exit from bottom of housing and assemble lens to housing (see illustration).
