1984-1986 JEEP WAGONEER/TRUCK

## **MODEL 208 TRANSFER CASE REVISION ANNULUS GEAR**

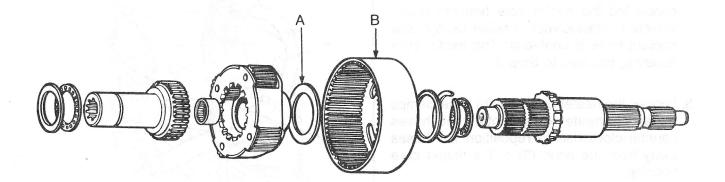
86493A

Two annulus gear assemblies were used in Model 208 transfer cases. They are interchangeable.

Type I has a metal hub annulus and does require a thrust washer.

Type II has a nylon hub annulus and does not require a thrust washer.

When replacing a Type I annulus gear with a Type II annulus gear (B), be sure to discard the thrust washer (A) located between the annulus and planetary gears.
